date and time of inspection: 1/1/03 at 8:00 am
property location: 123 First Street
date report mailed: 1/2/03
inspection number: 3398
inspector: Glenn Vernon
not paid at time of inspection: \$000

This report contains the following:

A. GENERAL INFORMATION

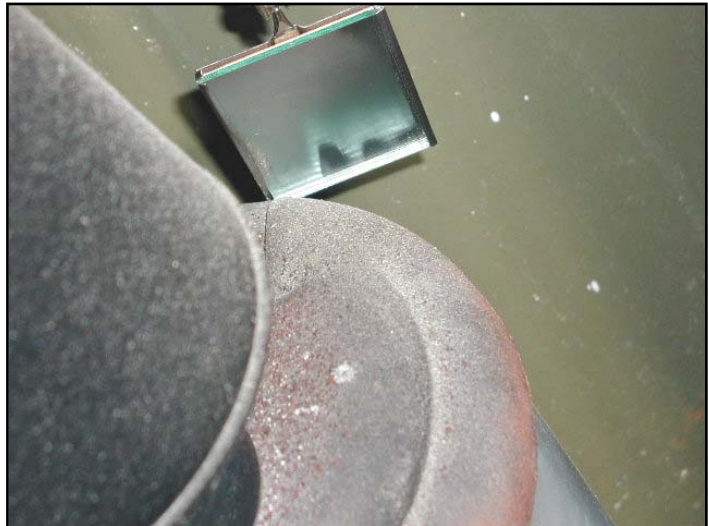
2. Hot water tank

Reason: Unsafe condition - There was leakage of combustion products from the “side-arm” heating component of the hot water tank whenever the tank was operating. This was evidenced by the moisture on the mirror as seen in the photo at right. This can result in carbon monoxide entering the basement. It is generally difficult to seal this type of tank and this type of hot water tank is relatively inefficient compared to today’s typical hot water tank. It was also noted that there was a significant pressure drop when the water passed through the tank, as evidenced by the low flow of the hot water, as compared to the cold water.

Recommendation: Repair/replacement of the tank is recommended.

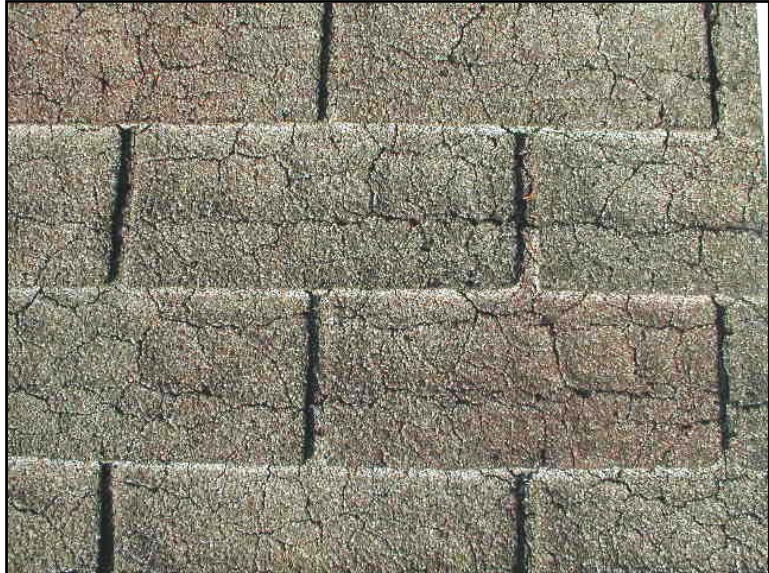
1. There were cracks all the way through the asphalt shingles on the front porch roof. See photo at right. The shingles on the upper level roof were in somewhat better condition because the slope was steeper; however, there were cracks in the "I's" of the shingles (slits between the tabs). This is an indication that the roofing shingles are nearing or at the end of their typical economic life and removal and replacement is recommended.

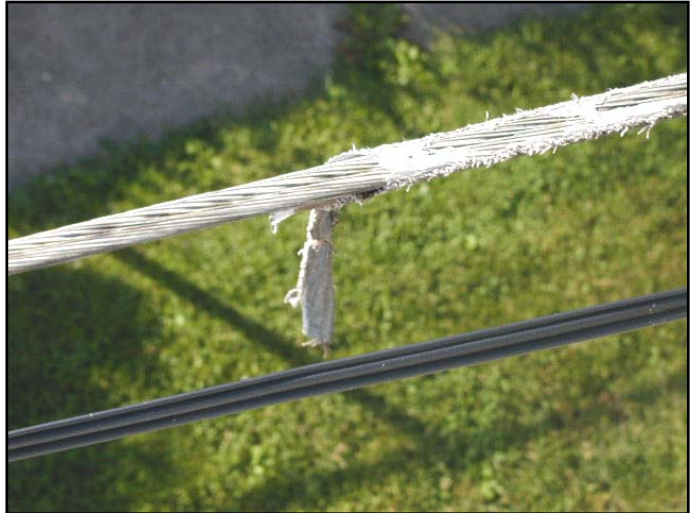
2. The insulation on the service entrance cable was frayed and the service line extended all the way along the left side and across the back of the house. See photo at right. A frayed cable may allow water leakage into the cable and panel and replacement of the cable is recommended. It is likely that the power company will require relocation of the electric service to the front left corner of the house.

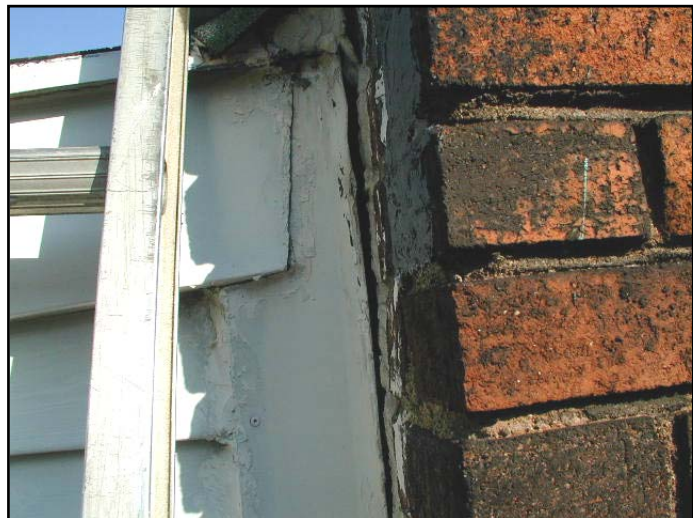
3. There were signs of settlement of the back addition, as evidenced by the separation between the addition and the brick on the main house area. This was particularly noticeable at the left side column (facing from the front). See photo at right. It was also noted that an intermediate post that had been installed between the two original columns had settled (and there was no weight on the post). There was a noticeable slope when walking in the addition and there were signs of separation on the interior wall

between the addition and the main house. It is recommended that the cracks be monitored for signs of additional movement in the future. If there is significant additional movement in the future, reinforcement or replacement of the foundation may be needed. It is not possible in the scope of an inspection to determine or predict whether or not there will be additional movement, rate of movement, etc.
