April 12, 2016

456 Street

GENERAL INFORMATION

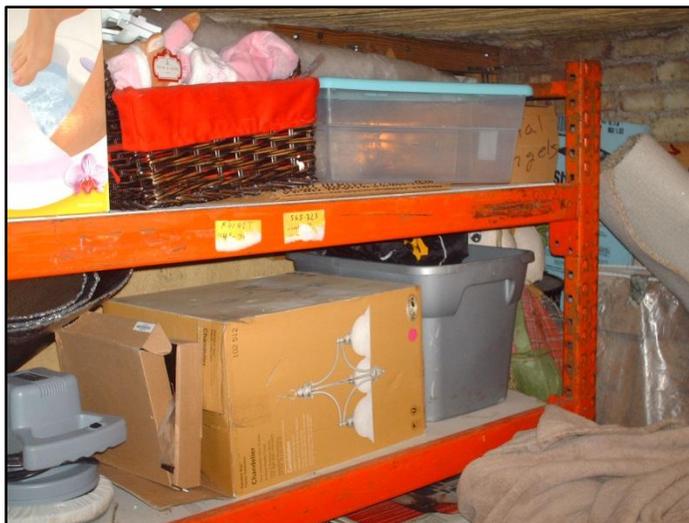
5. There were numerous stored personal items in the right side cold storage room, which restricted view of this area. This condition is illustrated in the accompanying photo.

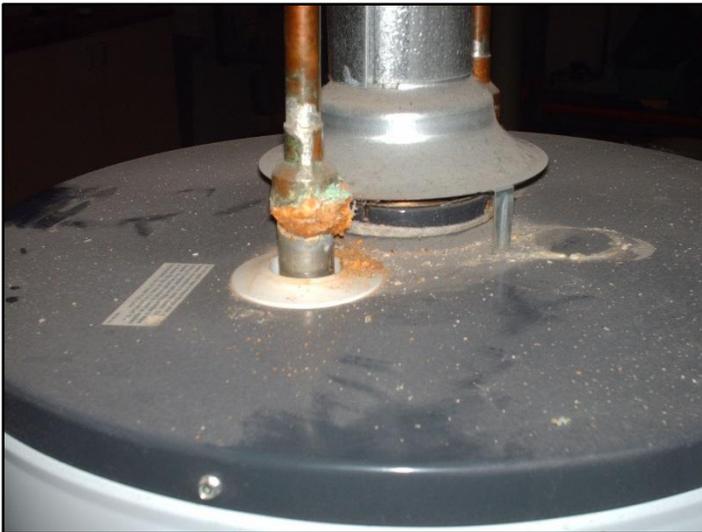
Corrosion was observed on the cold water fitting directly above the hot water tank. It is recommended this be repaired or replaced by a plumber. This condition is illustrated in the accompanying photo above left.

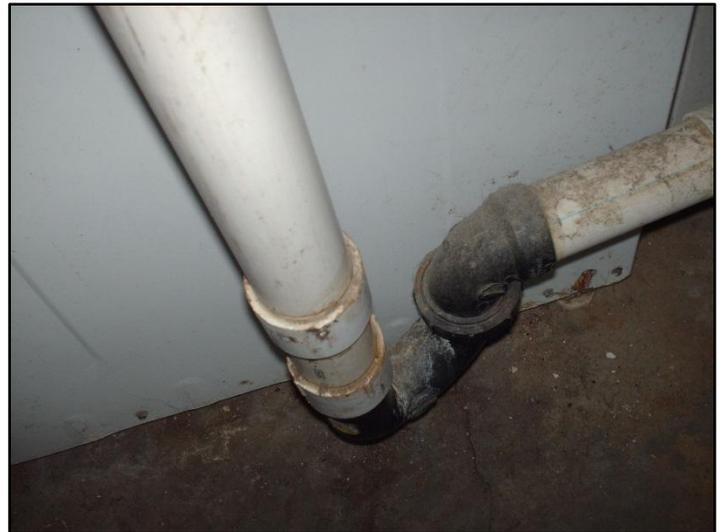
There is ABS plastic and PVC plastic pipe intermixed as seen behind the washing machine in the basement. This is not a recommended installation, as typically the solvents for these pipes are not compatible. No active leakage was observed from this area when the plumbing fixtures were operated. This area should be monitored. This condition is illustrated in the accompanying photo above right.

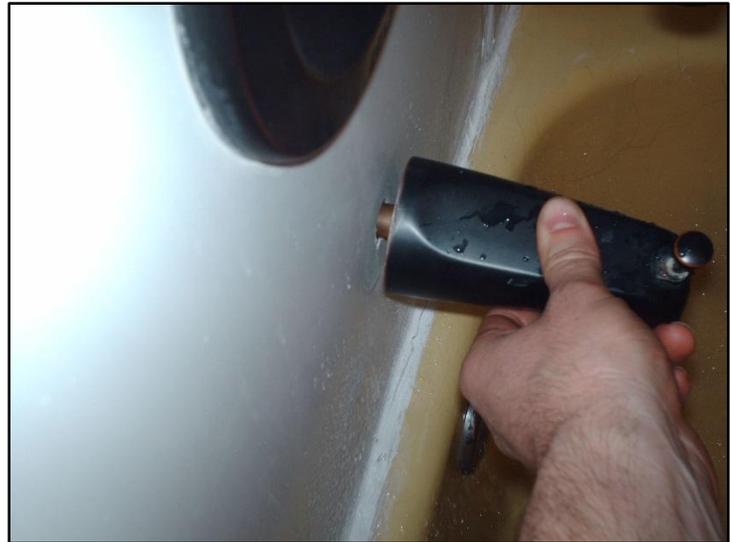
The tub filler in the hall bathroom on the second floor was loose and was able to be pulled from the wall. This condition is illustrated in the accompanying photo. It is recommended that this be tightened and re-secured.

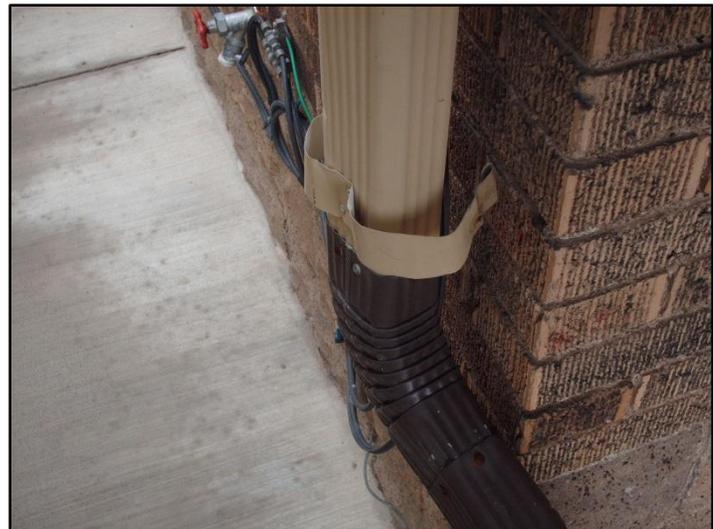
12. The downspout at the front left corner of the house was minimally secured to the house. It is recommended that additional support straps be installed. This condition is illustrated in the accompanying photo.

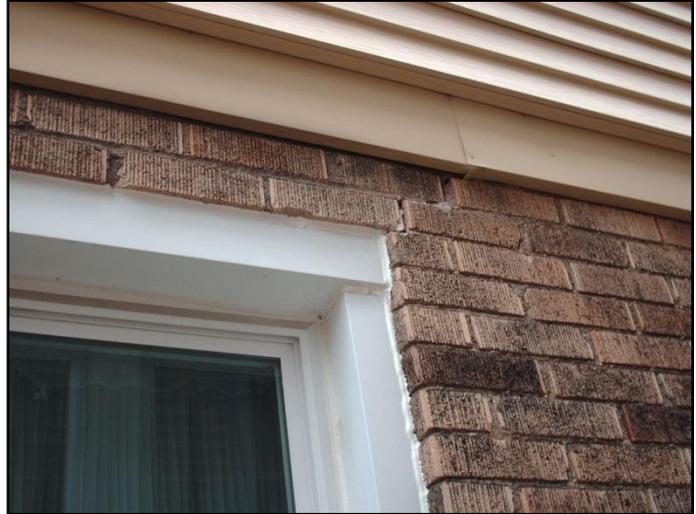
15. Step cracking and past patching repairs were observed above the left side first floor window. This condition is illustrated in the accompanying photo. It is recommended that the step cracks be patched and repaired by a mason. It is also recommended to monitor this area for signs of additional movement.

A similar condition was also observed above the rear window in the brickwork.

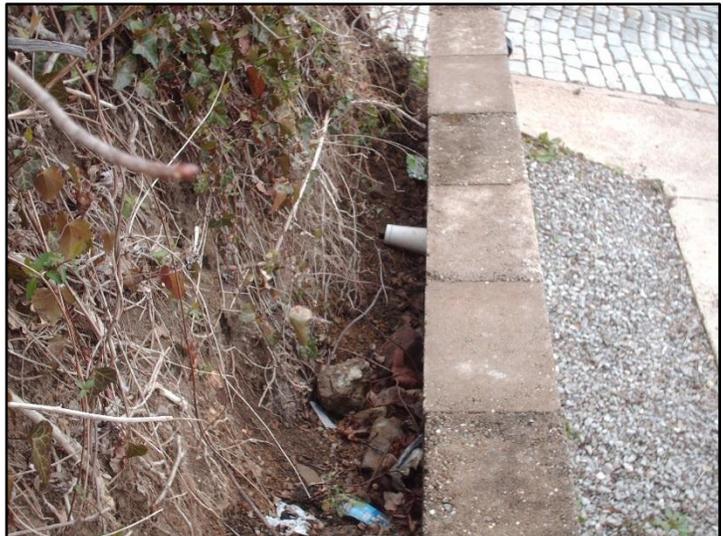
18. A concrete block retaining wall had been installed along the perimeter of the parking pad at the back of the property. It appeared that French drain pipe had been installed along the edge; however, not all of the earth and dirt had been refilled adjacent to the retaining wall, particularly on the uphill left side of the retaining wall when facing from the front of the property. You may wish to consider installation of gravel or shale behind this area to help promote proper drainage. This condition is illustrated in the accompanying photo.

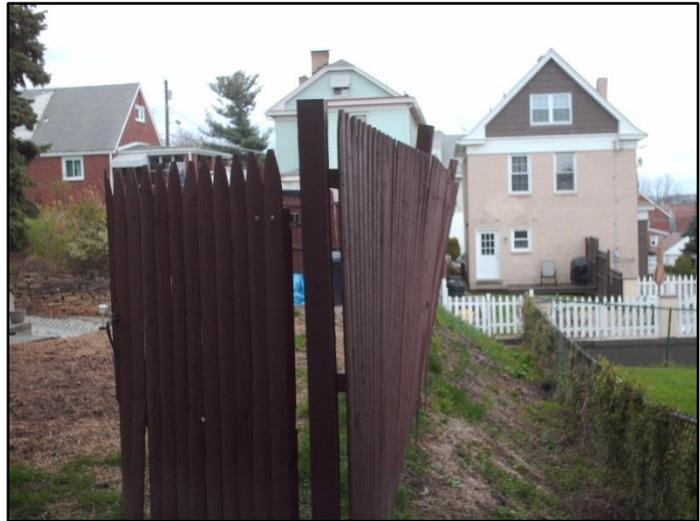
19. It is beyond the scope of this inspection to inspect fences; however, the fence along the right side to the rear yard (when facing from the front) was missing several wooden slats. The fence was also noted to be leaning downhill significantly in the middle span of the fence. It is recommended that you consult with a landscaping contractor regarding repairs to the reset the fence posts and to add additional slats to repair the missing or broken slats. This condition is illustrated in the accompanying photo.

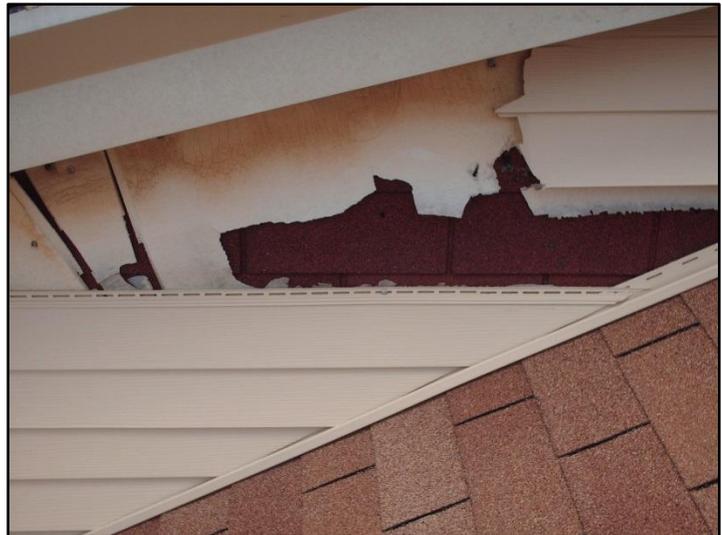
21. Sections of the siding had become detached from the right side third floor dormer. It is recommended that the missing sections of siding be replaced. This condition is illustrated in the accompanying photo.

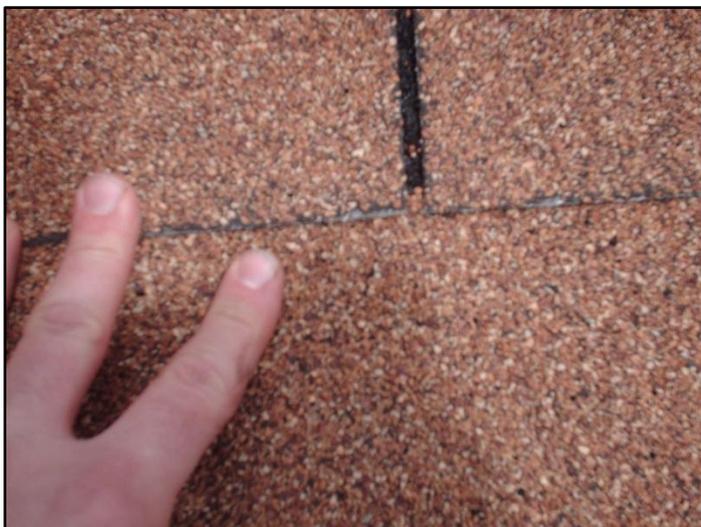
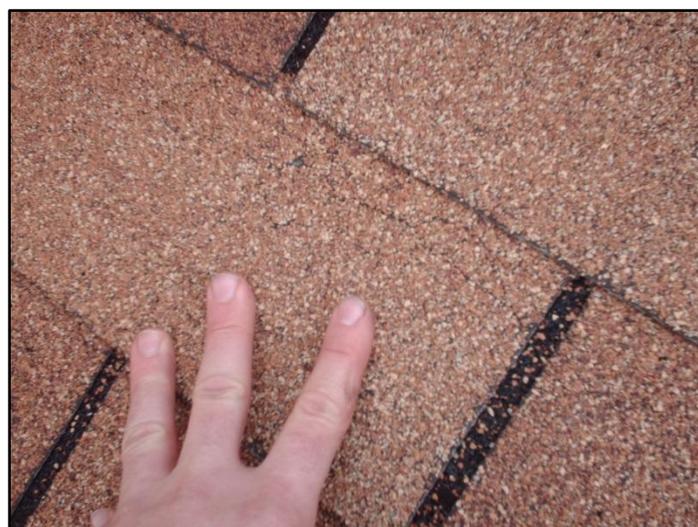
23. Granule loss was observed from the edges of shingles at the front and rear roof. Surface cracks were observed on the front roof (southwest facing side). The shingles are estimated to be approximately 12 – 15 years old. There did not yet appear to be cracks in the eyes of the shingle (space between the tabs). As cracking, deterioration and aging continues, blow-offs may occur. The typical service life for an asphalt shingle roof is approximately 20 – 25 years. This condition is illustrated in the accompanying photos above.

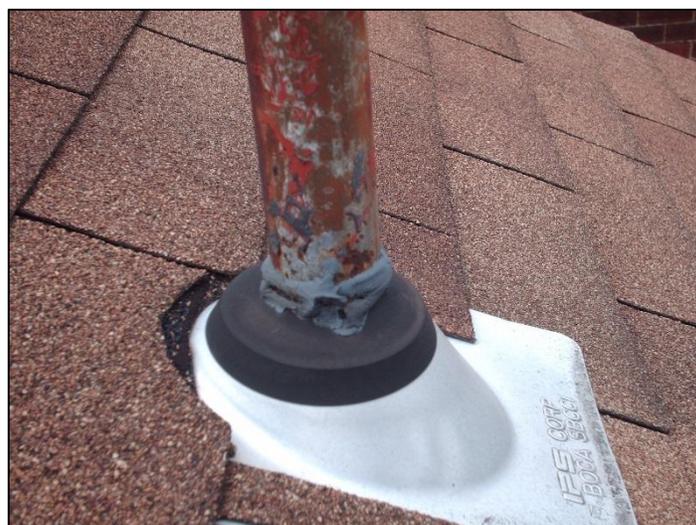
There was evidence of past patching or caulking to reseal the plumbing vent flashing at the back side of the roof. This condition is illustrated in the accompanying photo right. It is recommended to monitor this area for signs of future leakage. Resealing or re-caulking this joint may be necessary.

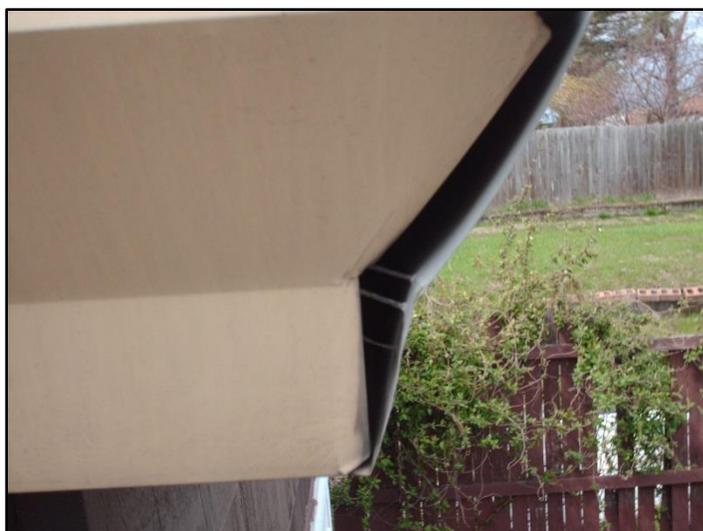
24. Some of the flashing at the eaves of the right side of the back bump out was beginning to pull loose from the house. This condition is illustrated in the accompanying photo. It is recommended that this be re-secured.

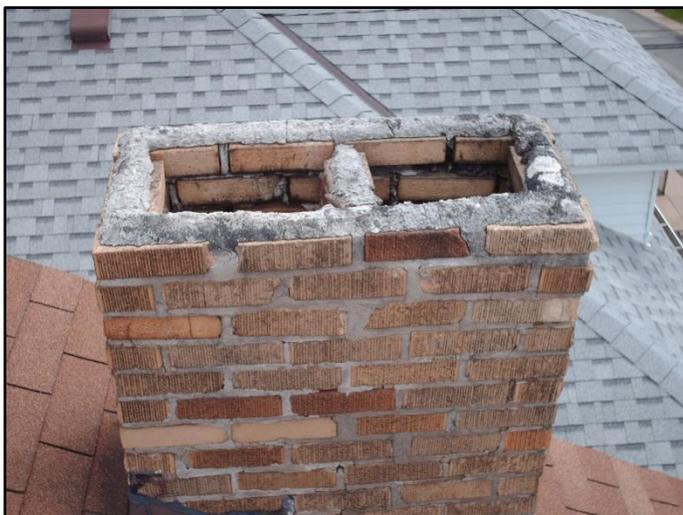
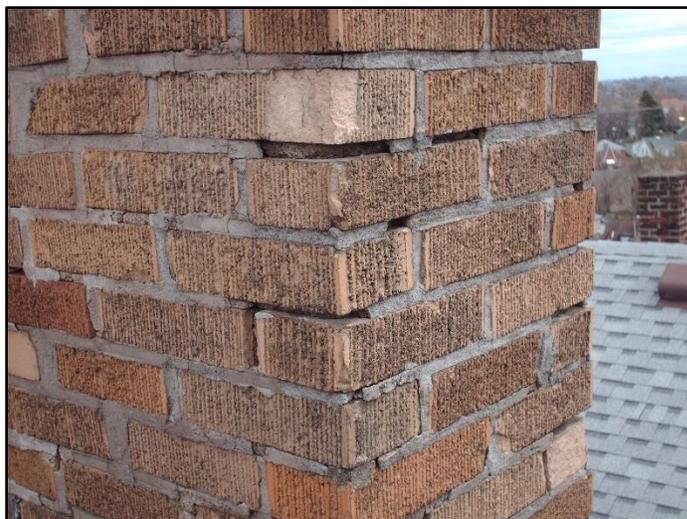
25. Spalling, cracking, and deterioration was observed at the cement crown at the top of the front right side masonry chimney. Loose and missing mortar and spalling brick was observed from some of the brickwork near the top of the chimney. Maintaining the integrity of the cement crown is important to prevent water entry at the top of the chimney. It is recommended that you consult with a masonry contractor regarding repair / replacement of the crown. This condition is illustrated in the accompanying photos above.

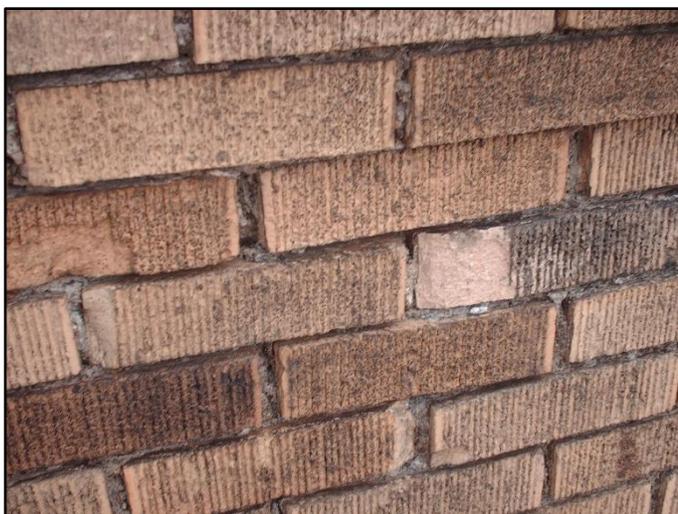
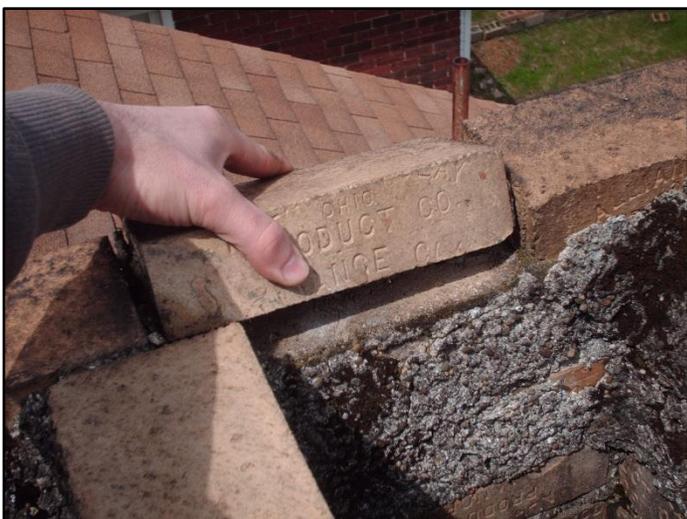
Loose and missing mortar was observed at the back left side chimney. There was no cement crown at the top of the chimney. There was loose brick observed at this chimney as well. This condition is illustrated in the accompanying photos above.

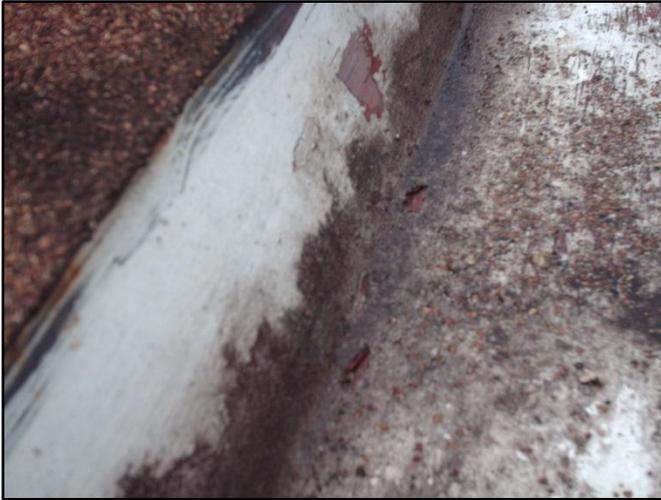
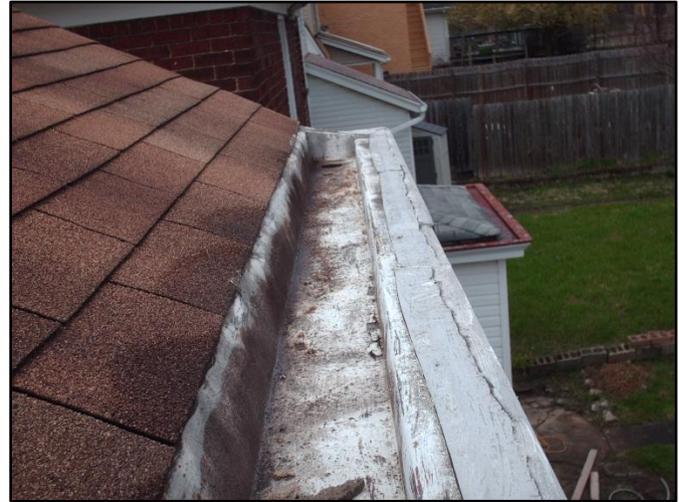
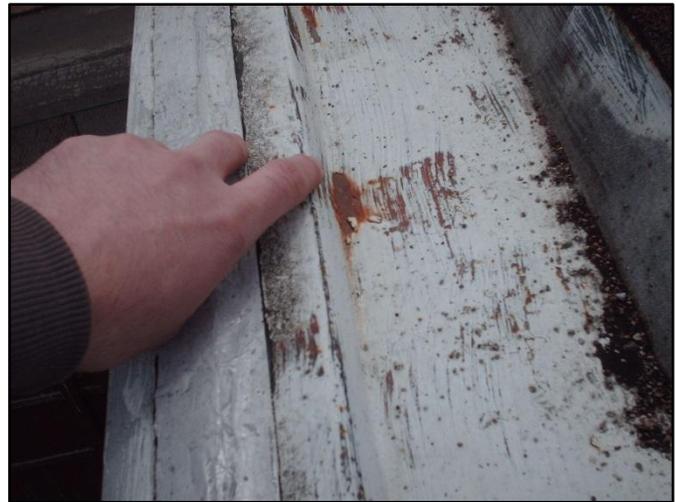
Surface rusting was observed at the upper level front and rear gutters. Painting maintenance is recommended. This condition is illustrated in the accompanying photos.

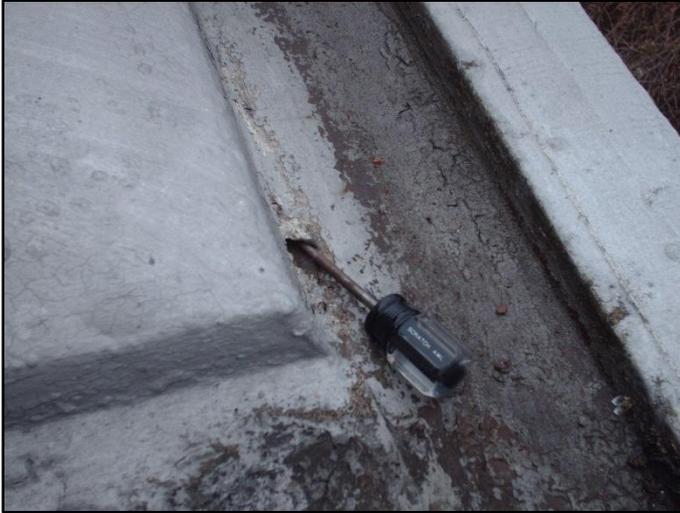
The front porch and back addition had been coated in aluminized roof paint. There were areas at the back addition that the paint was beginning to bubble and peel away. It is recommended that these areas be repainted to prevent excess rusting and deterioration of the metal roofing and box gutter. This condition is illustrated in the accompanying photo above left.

It is recommended that you consult with a roofing contractor regarding the exact scope of repairs appropriate for the above mentioned items.

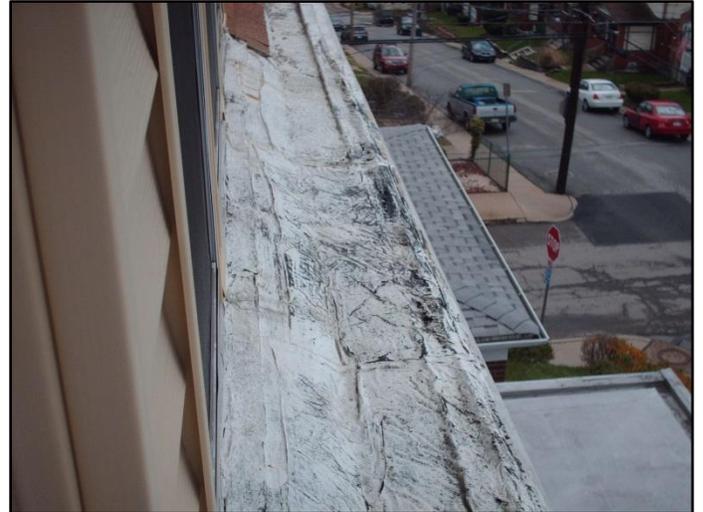
There appeared to be some patching to the box gutters as seen at the front third floor dormer. Some of the paint and patching was beginning to wear and deteriorate at this area. This condition is illustrated in the accompanying photo above right.

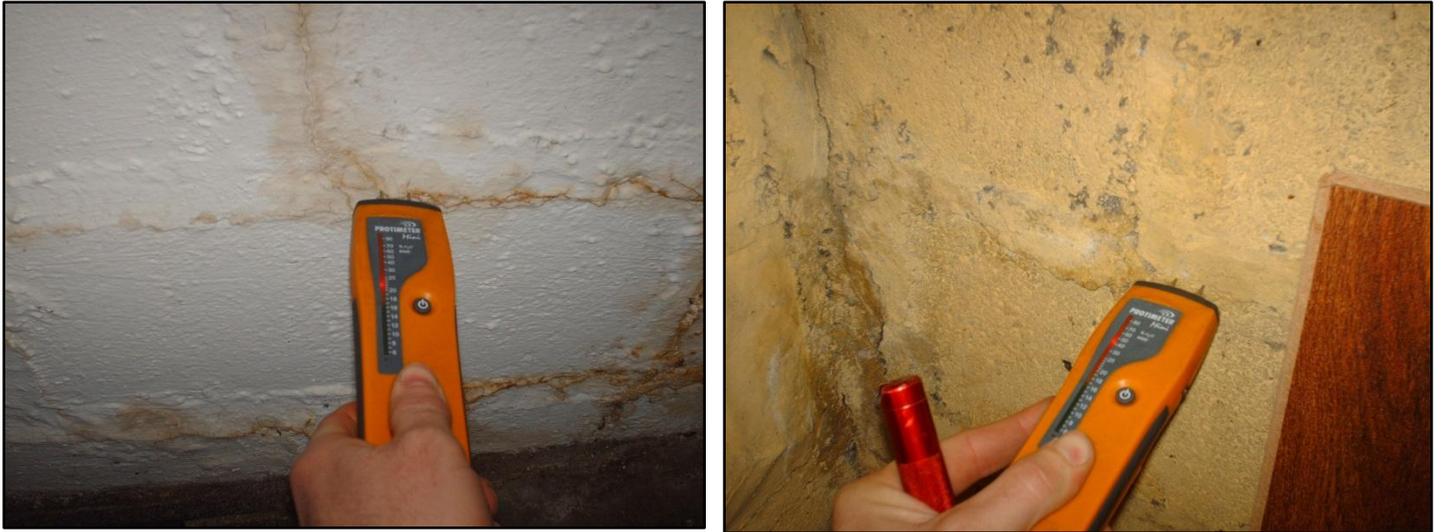
28. Staining, efflorescence and signs of past water penetration were observed on the foundation walls at the front right corner of the basement. When checked with an electronic moisture meter, some of these areas were wet or damp at the time of the inspection (35% - 45% moisture). This condition is illustrated in the accompanying photos above.

In general, the house pre-dates the era of modern water-proofing and damp-proofing coatings. A dehumidifier should be operated to help control moisture and humidity at the basement.

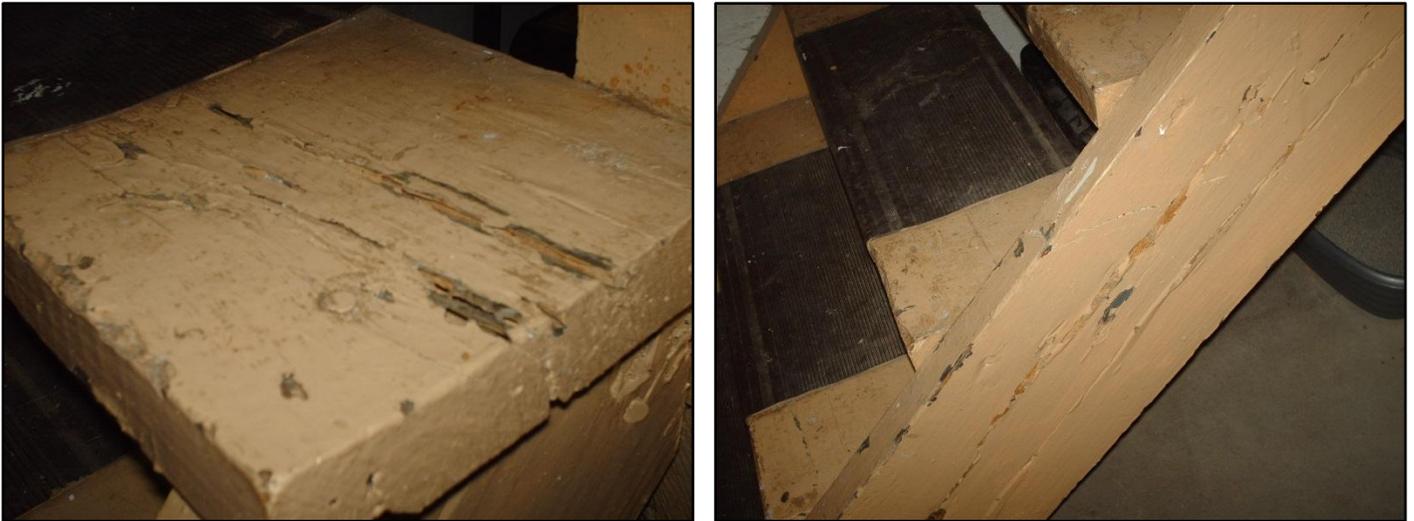
30. There is evidence of past termite infestation on the stringer and treads to the basement staircase. This condition is illustrated in the accompanying photos above. Drill marks indicative of past treatment for termites were observed in the basement floor. Evidence of past repairs was observed at the affected framing. You should consult with the current owners regarding any history of past pest control activity on the property. Any records or warranties should be retained, and these areas should be monitored for new activity.

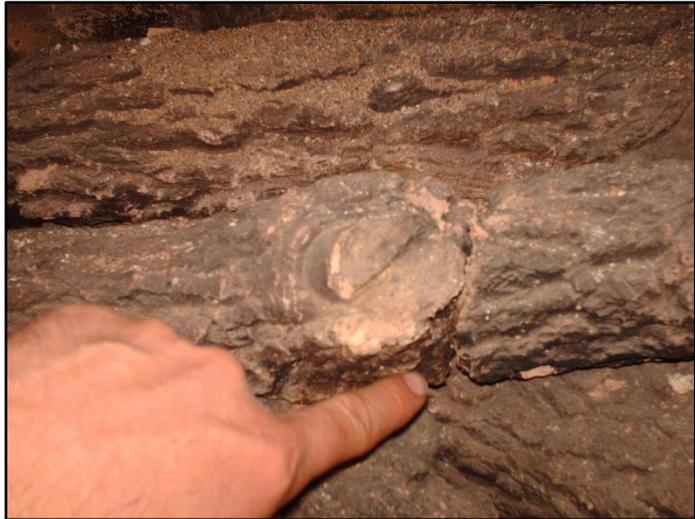
The ceramic logs in the fireplace do not appear to be arranged correctly, which can interfere with safe operation. In addition, there was a large crack through one of the logs which can affect air flow. This condition is illustrated in the accompanying photo. It is recommended that the logs be cleaned and correctly configured. You should consult with the manufacturer's literature or a gas log specialist regarding proper log placement.

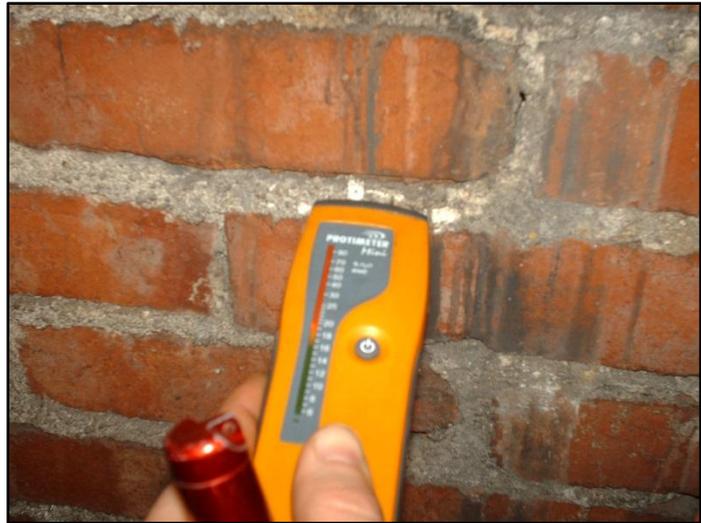
40. When checking the chimneys in the attic with a moisture meter they were damp at the time of the inspection. This suggests that water is wicking through the brickwork from the roof. You may consider installation of a rain cap. This condition is illustrated in the accompanying photo.
