PROPERTY INSPECTION REPORT

Inspection Address: 123 Main St
Inspection Prepared For: Joe Sample

Date of Inspection: 10/1/2022
Year Built: 1950 Size: 1200 sf
Weather: 60-65 degrees and clear

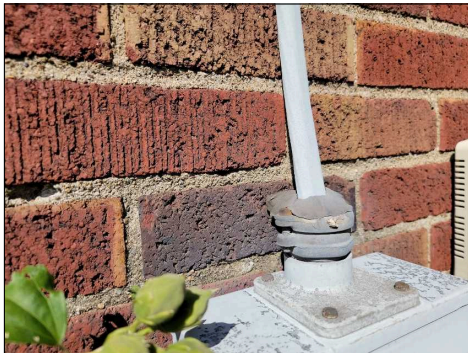
A.3. The duct seal at the top of the electric meter socket was cracked and deteriorated. Replacement is recommended to help prevent water entry into the electric service.

Duct seal at the top of the electric meter socket deteriorated

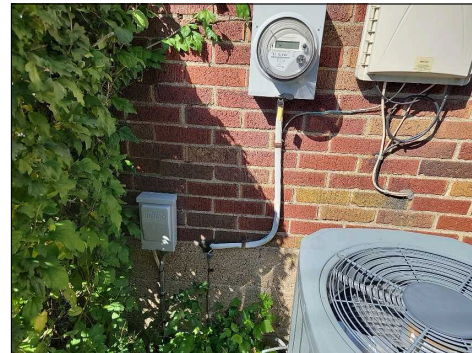
A.2. A section of the electric service entrance cable was exposed below the meter socket and may be subject to damage. Installation of a conduit or cable U-guard should be considered as an added measure of protection.

Section of the electric cable below the meter socket at risk of damage

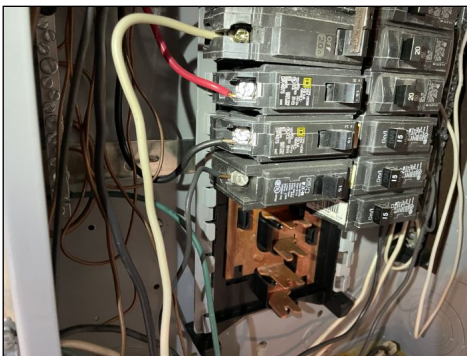
B.3. There was a strand of three-wire being used for 120-volt breakers (two hot, one neutral) in the main panel. Typically, when this condition exists, the breakers will be bridged together so that both breakers would trip at the same time to not have a shocking hazard. It is recommended that a bridge or coupler be installed.

There was a strand of three-wire being used for 120-volt breakers

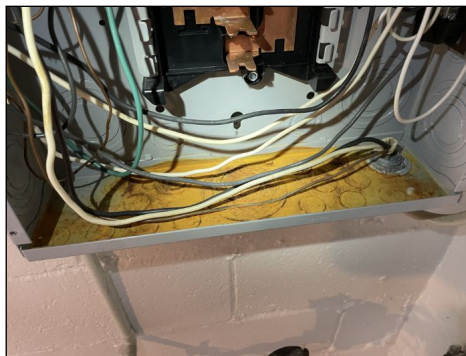
Rust at bottom of main panel

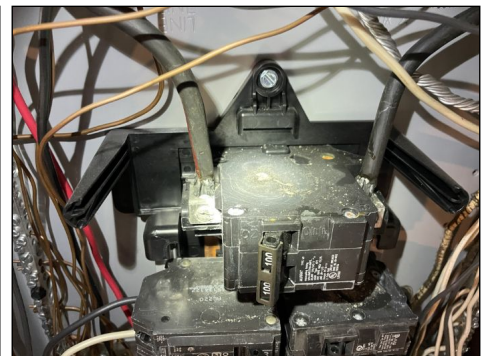
B.2. There was evidence of past water entry into the main electric panel. Minor corrosion was observed on the service grounding conductor in the panel, on the main service lugs to the shut off, a few breakers in the panel, and rust stains were observed at the bottom of the panel. In general, the corrosion did not appear to be extensive, and had not yet affected terminals, bussbars, or breakers elsewhere in the panel.

Corrosion in main panel

Maintaining the duct seal at the meter socket at the exterior is important to help prevent water entry. It is recommended that this condition be evaluated and monitored in the course of

repairs and updates to the electric system. Any affected conductors or connections should be cleaned by an electrician.

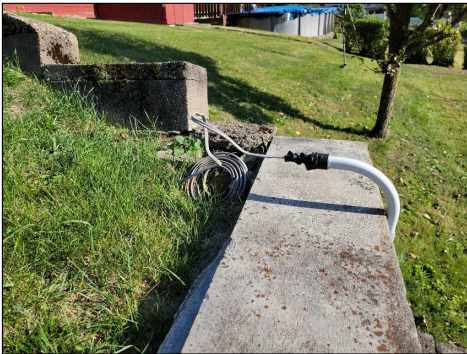
D.9. An exposed wire was observed at the back exterior at the right side of the retaining wall. The wire was checked with a sniffer and found not to be live at the time of the inspection. It is recommended that it is removed if desired or consult with an electrician about future updates.

An exposed wire was observed at the back exterior

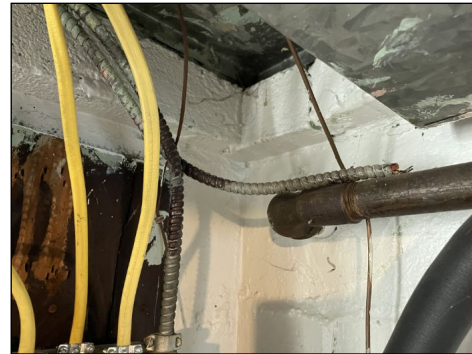
D.8. There was a cut unused metal sheathed wire dangling above the electric panel in the basement. This did not appear to be live; however, it is recommended that this be capped or removed to prevent confusion.

Cut wire dangling above electric panel

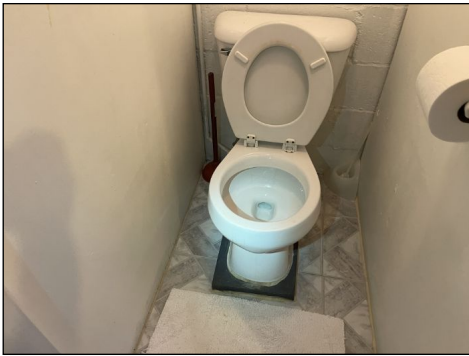
D.12. The basement toilet continued to run after it was filled. This was observed running when the inspector entered the house. This could significantly increase your water bill if this continues. It is recommended that this be evaluated and repaired.

Toilet continuing to run in basement

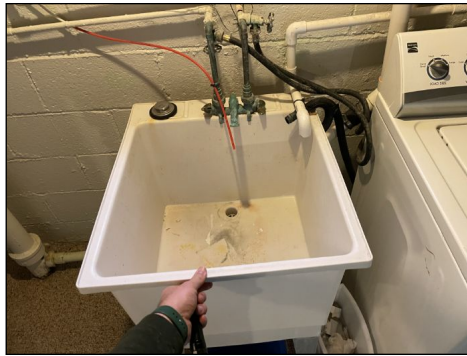
D.4. The laundry sink was not secured to the wall or the floor in the basement. It is recommended that this be secured to prevent a possible tipping hazard.

Laundry sink not secured to wall or floor

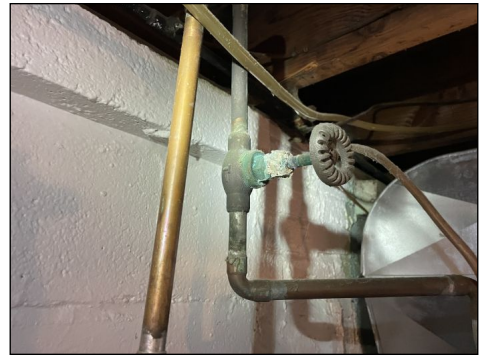
D.1. Slight seepage was observed on a valve above the laundry sink in the basement. This should be evaluated and repaired by a plumber to prevent possible damage or moisture in the living spaces.

Suspected seepage and corrosion on valve above laundry sink

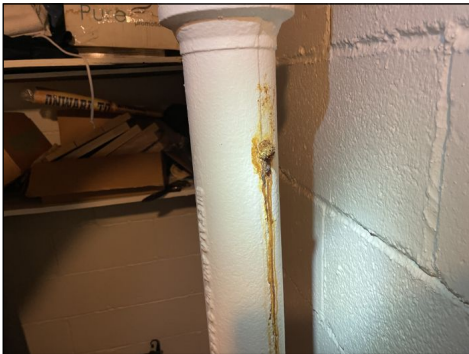
Rust blisters on drain stack

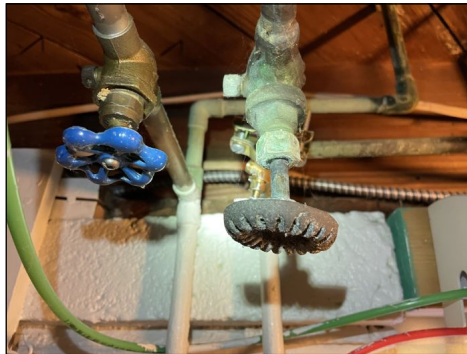
Corroded valves that may not function properly

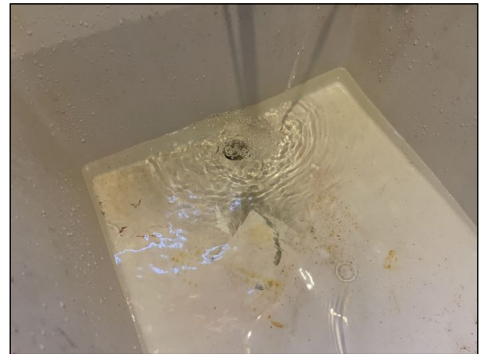
D.5. There was slow drainage to the laundry sink in the basement. It is possible that this is the result of blockage which can be corrected using a plumber's snake. This could also be the result of the S-trap below the laundry tub slowing the drainage. It is possible that more extensive repairs will be needed. You should consult with a plumbing contractor regarding this.

Slow drain in laundry tub

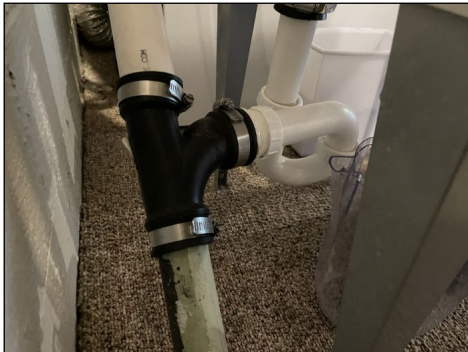
S-trap below laundry tub

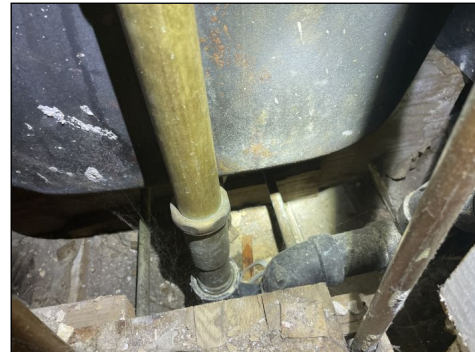
D.13. Leakage was observed below the tub to the second-floor bathroom as seen in the access hatch. It is recommended that the leaking tub be evaluated had repaired. As a note, this may be the cause of the damaged to ceiling in the living room.

Leakage from tub to second floor bathroom

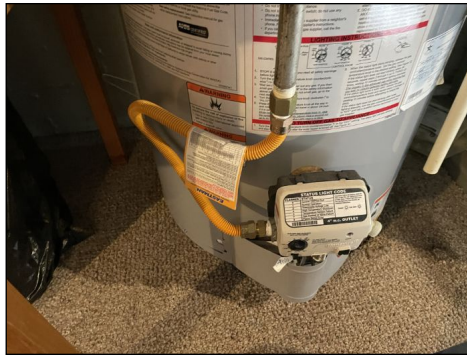
E.2. There was a drip leg lacking from the piping providing fuel to the water heater. Typically, there should be a drip leg or sediment trap at each appliance connection to allow moisture and sediment to collect so that it does not enter the burner. Installation of a drip leg by a plumber is recommended.

No drip leg on gas line to water heater

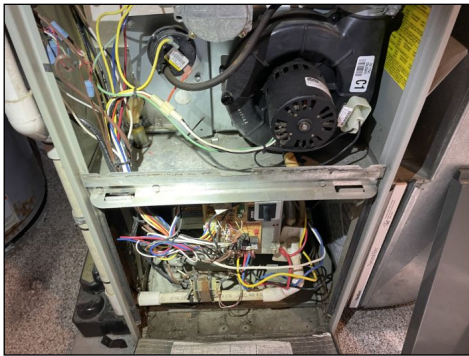
B.4. There was some minor rust and dirt observed in the blower compartments to the furnace. Prior to closing the furnace should be checked, cleaned and evaluated by an HVAC technician.

Dirt and rust in the bottom blower compartment to furnace

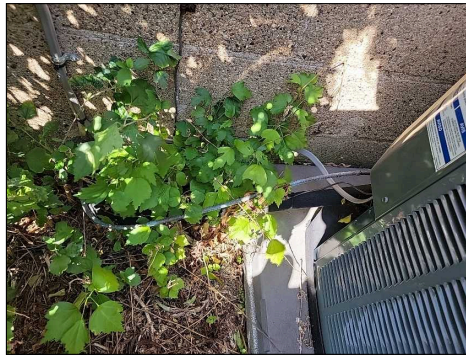
E.2. The insulation on the refrigeration tubing from the air conditioning condenser was blocked by vegetation at some areas. It appeared that some of the insulation was missing or damaged. Replacement of the insulation is recommended to help conserve energy and prevent condensation.

Insulation on the refrigeration tubing from the air conditioning condenser

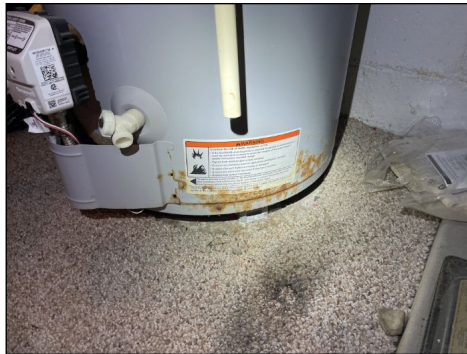
B.3. There was rust along the bottom of the water heater. This was particularly seen on the side where the **TPR valve** discharges. This could be a result of some moisture discharging from the pipe in the past. This could also be a result of leakage from the tank. This should be evaluated by a plumber during the course of repair to the drip leg on the gas line.

Rust on the bottom of the water heater

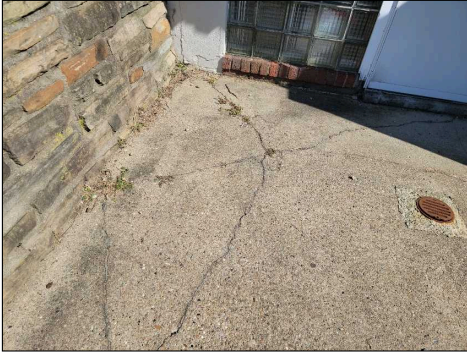
Various cracks to the concrete driveway

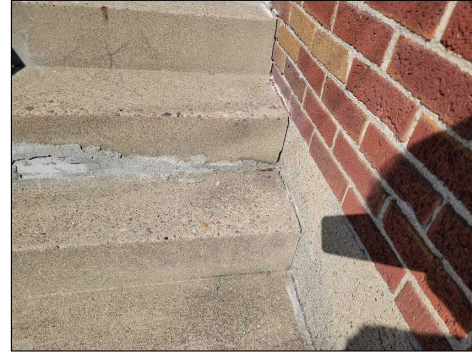
A.3. There were areas where gaps were seen between the concrete sidewalks and the foundation walls. This was also seen where the steps to the porches meet the foundation walls. These joints should be sealed to help prevent excess water penetration behind.

Gaps between steps and foundation wall that should be sealed

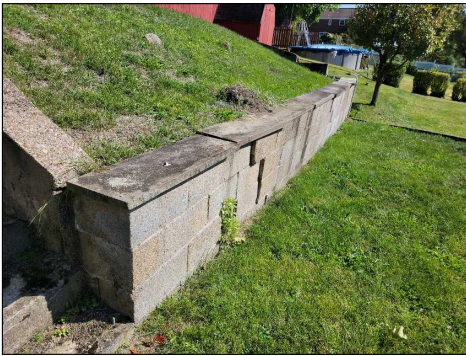
Cracked retaining walls at the rear

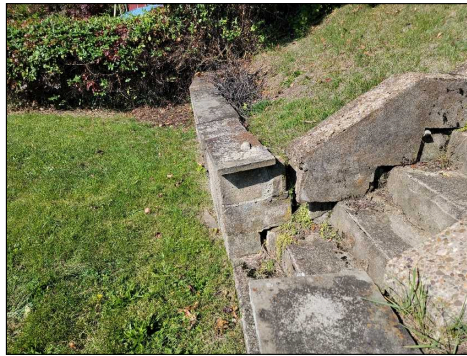
Retaining wall movement near back steps

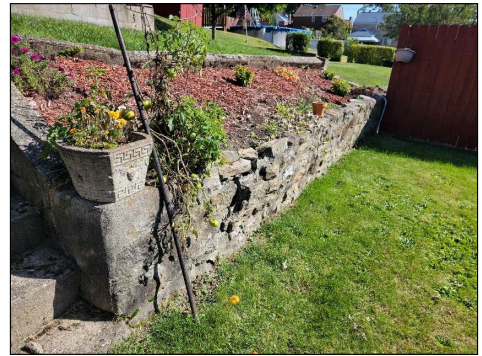
Bulging / leaning retaining wall at the back

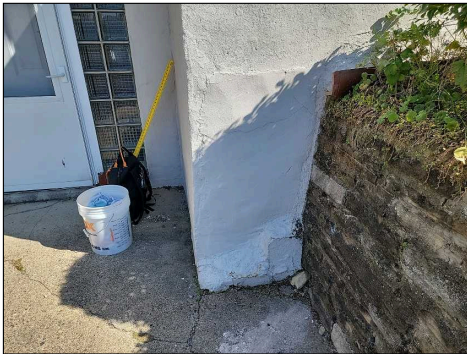
Cracks to the parge coat at the front foundation wall

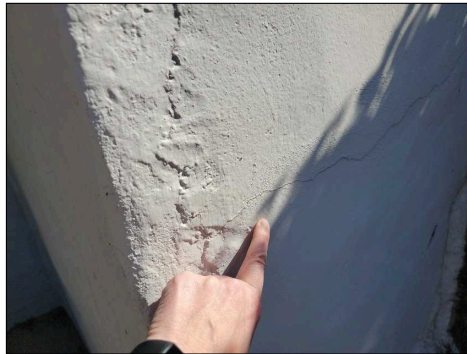
Cracks to the parge coat at the front

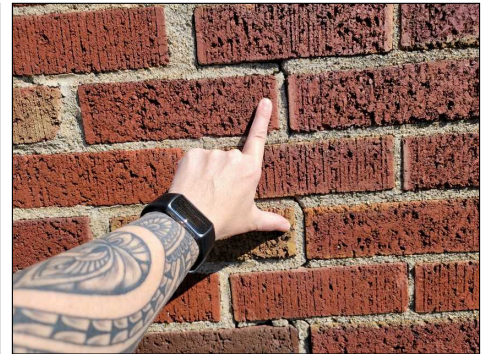
Step crack observed under the front right window.

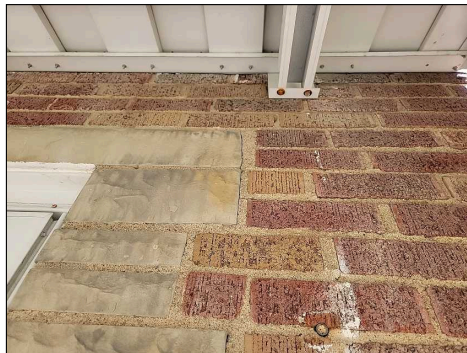
Hairline masonry cracks around some of the doors and windows

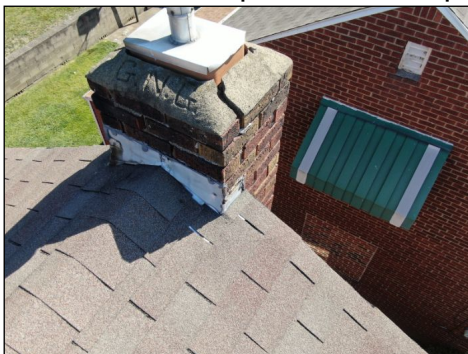
Cracked chimney crown

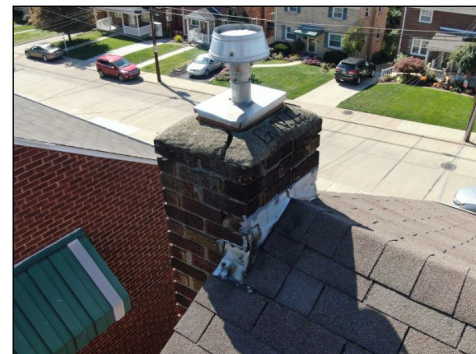
B.2. There were some areas of loose and missing mortar to the chimney. It is recommended that these areas be pointed and repaired.

Loose mortar to the chimney

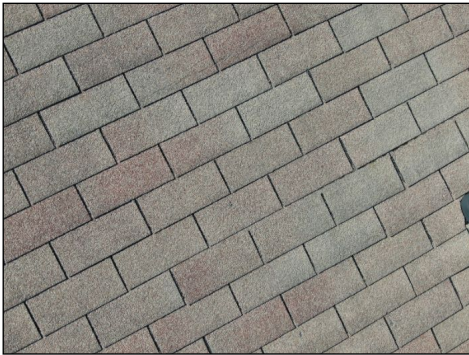
Granule loss and cracks to the roof

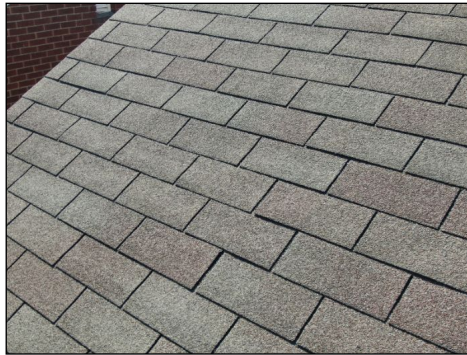
Cracks seen to the shingles on roof

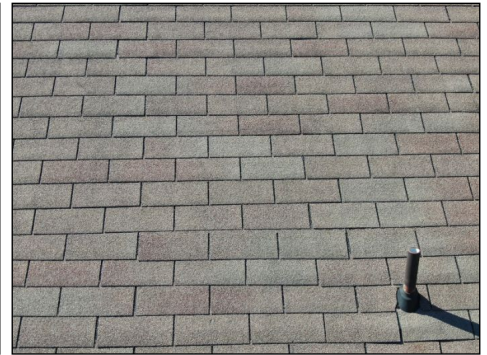
Some shingles slightly offset at the rear roof

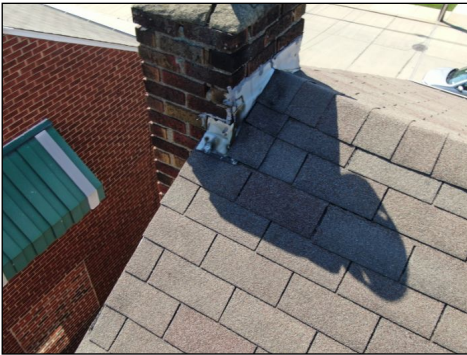
Chimney flashing needs to be resealed

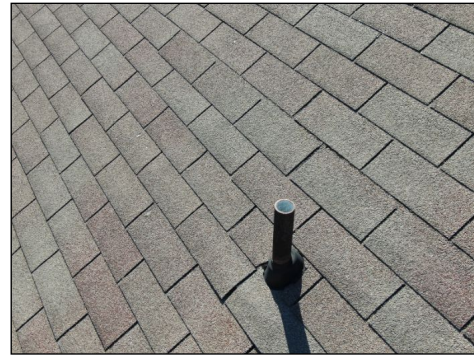
Shingles installed over bottom apron of plumbing vent flashing

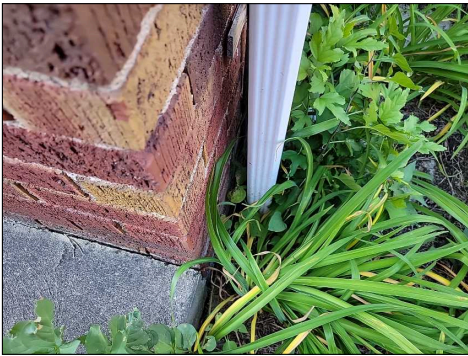
Downspouts that connect to underground drain pipes below grade

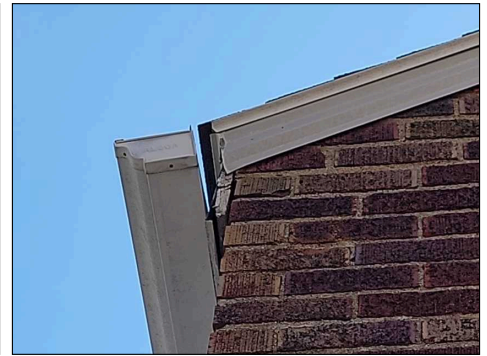
D.6. The gutter at the back of the home appeared to be minimally secured to the fascia. It is recommended that the gutter be secured to the home.

Gutter pulling away from fascia

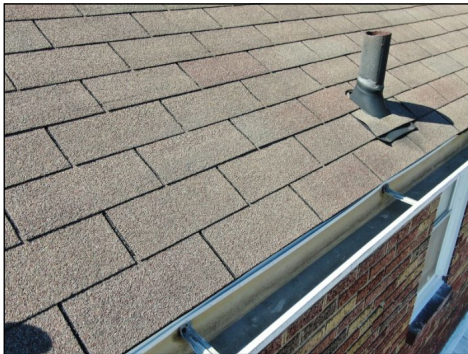
No drip edge flashing observed

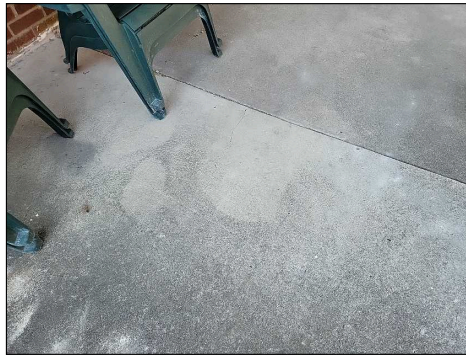
Cracks to the concrete slab observed at the back patio area

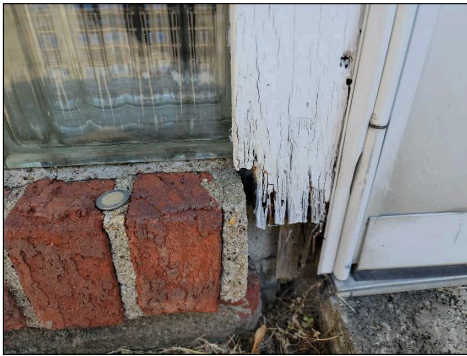
Rotted wood observed at the front basement door

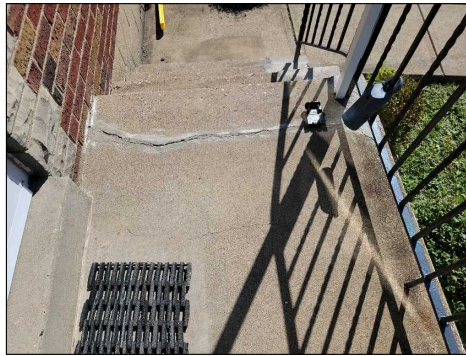
Cracks and deterioration to the concrete slab of the front porch.

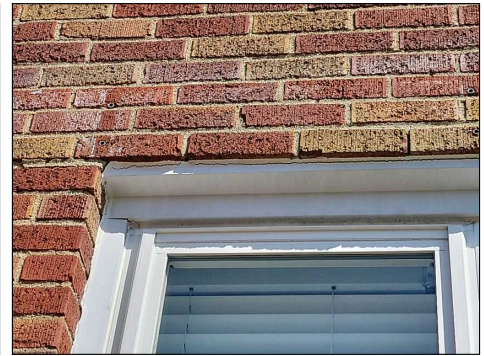
Most lintels sealed in flashing limiting view

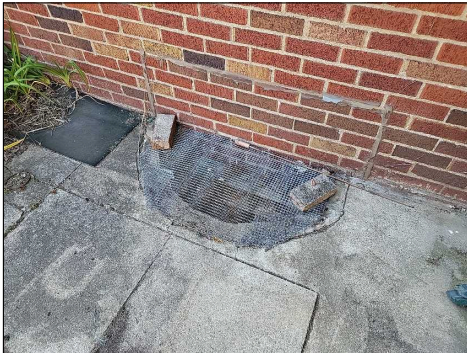
B.6. A makeshift window well cover was observed at the back exterior of the home. This is not a typical installation. It is recommended that a window well cover be installed at this location.

Makeshift window well cover

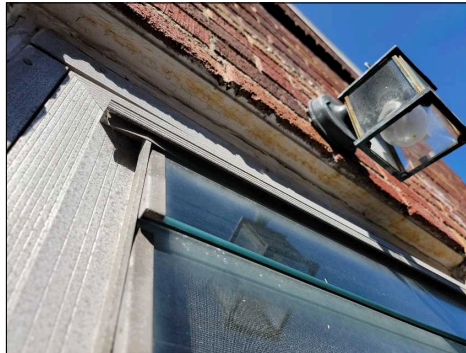
Rust on the steel lintel above the door

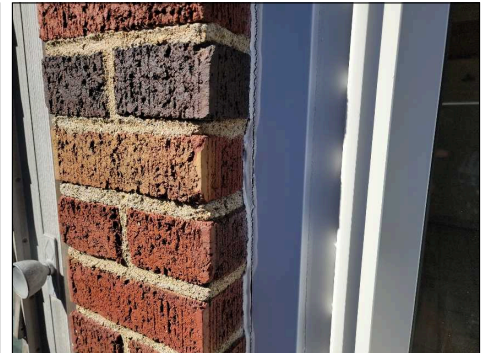
Dried and cracked caulking around windows and doors

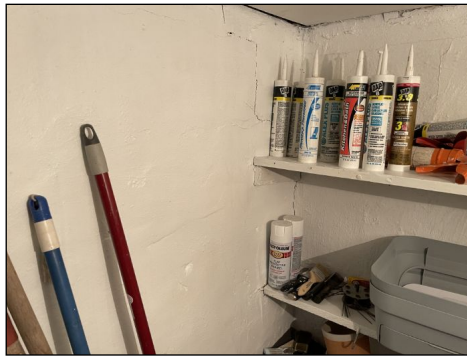
Cracks to the walls in the room below porch

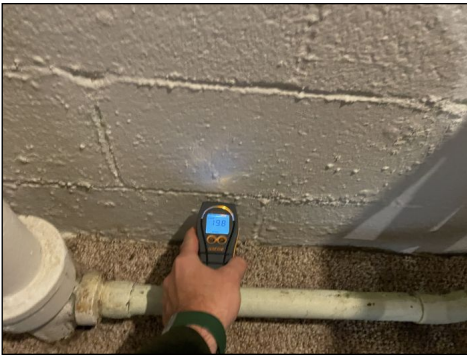
Moisture on walls in basement

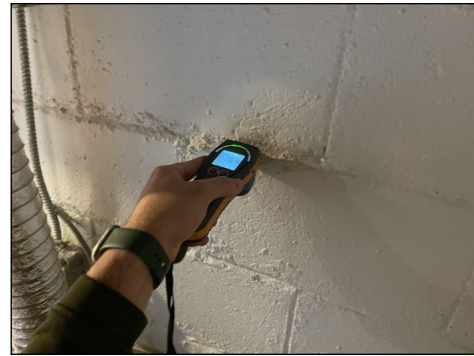
Staining and efflorescence on walls in basement

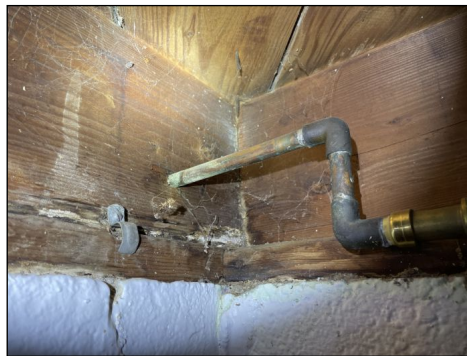
Some minor rot and signs of moisture on floor framing at back right in basement

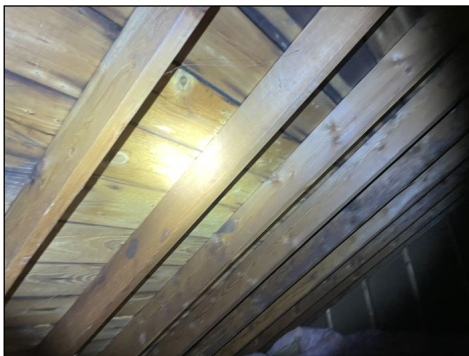
Possible mold at some areas in attic

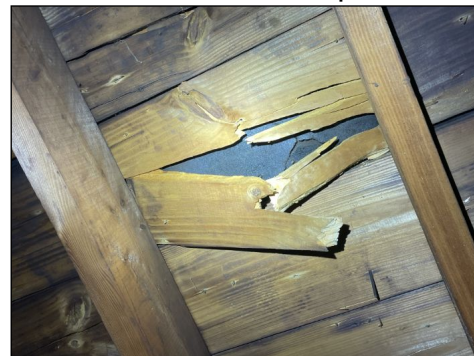
B.3. Cracks and some broken roof deck boards were seen in roof sheathing. This is not uncommon for older homes with a board roof deck. These areas should be repaired.

Broken roof deck boards in attic

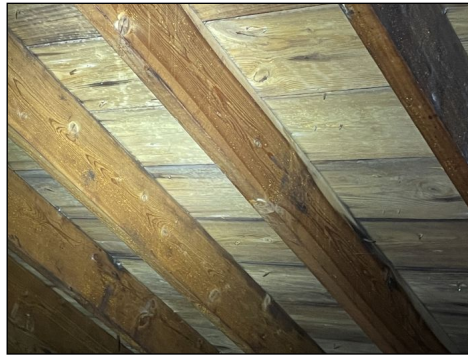
Staining on roof nails to roof deck in attic

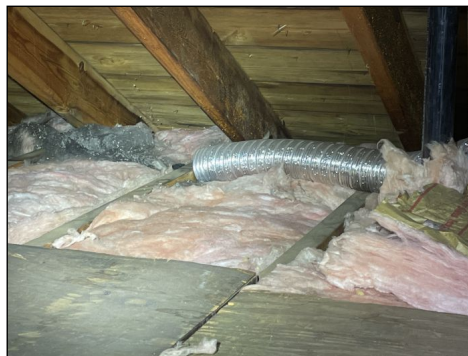
D.1. The bathroom ventilating fan was discharging directly into the attic. Although once common, this is not a recommended installation. This can allow excess moisture to accumulate in the attic, which may lead to condensation, deterioration, mold, etc. Installation of insulated metal ductwork is recommended to discharge fan exhaust directly to the exterior. You should consult with a roofing contractor or handyman regarding this.

Bathroom vent fan discharging into attic

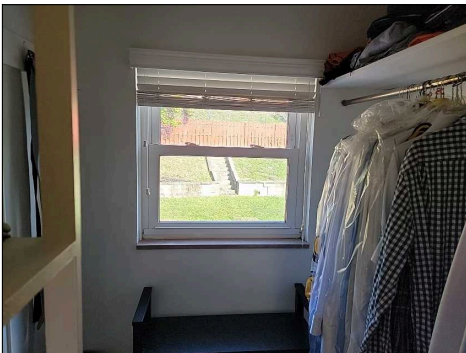
Defective sash-balance-mechanisms to the back window in the left bedroom

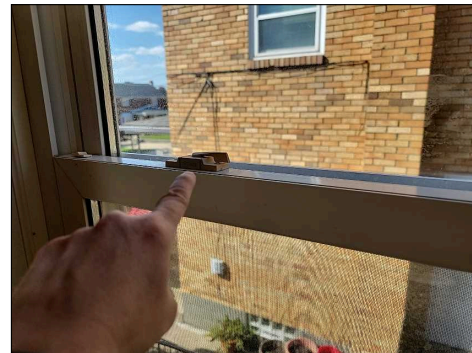
Window sashes would not line up to lock

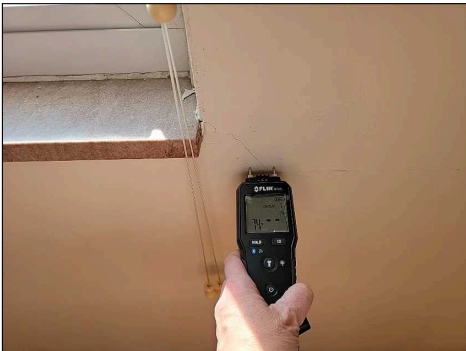
B.2. Repaired areas and cracks were observed to the bottom corners of windows in the front left bedroom. These areas were checked with a moisture meter and were found to be dry at the time of the inspection. It is recommended that the cracks be repaired and monitored.

Repaired areas and cracks were observed around windows

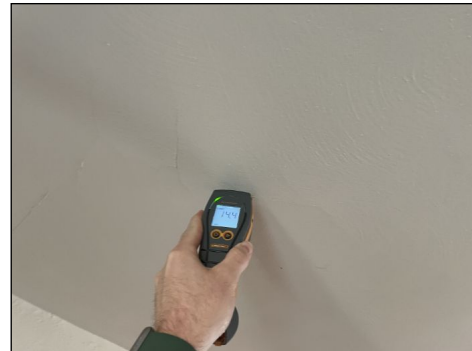
Stain and cracks to living room ceiling from bathroom leak

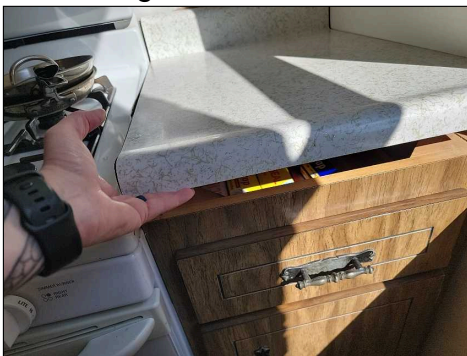
Kitchen countertop was not secured to the cabinetry

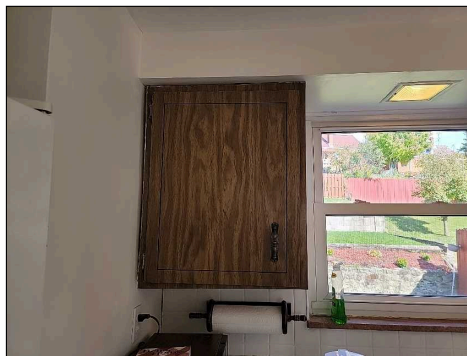
C.7. Misaligned cabinetry was observed in the kitchen. It is recommended that the cabinetry be realigned.

Misaligned cabinetry was observed in the kitchen

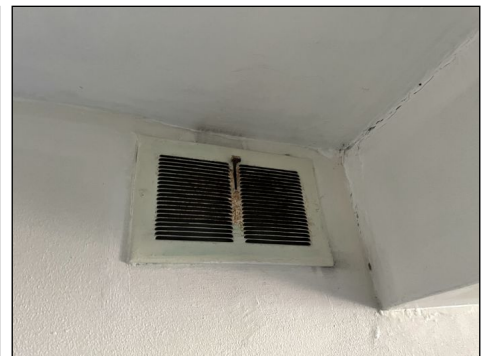
Open vent in left room of basement that may need to be sealed off for future garage

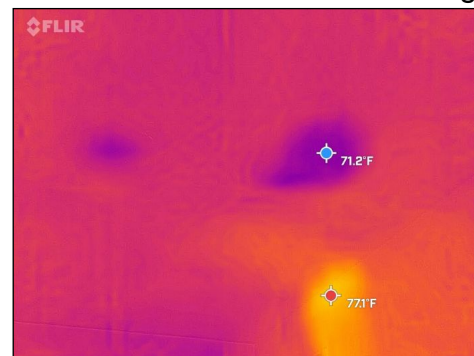
Infrared camera showing cool area in living room ceiling from leakage

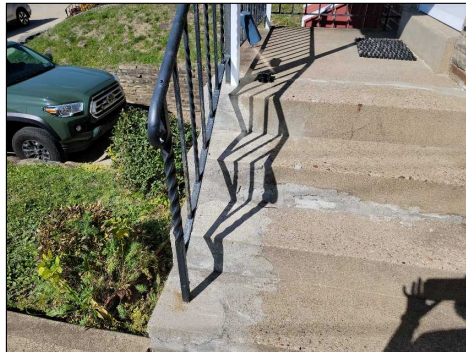
The steps and railing to the front porch had evidence of previous repairs.
