HOME BUYER REPORT

Buyer Name
Buyer Address
Pittsburgh, PA 15220

Inspection Date and Time
Inspection Address
Jason Greenawalt
\$XXX Total Fee
\$XXX for general inspection
\$XXX for wood destroying insect inspection
\$XXX for radon inspection

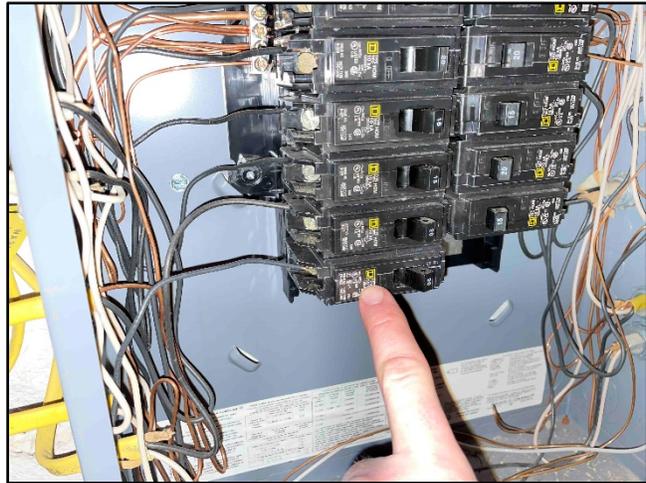
- f. There is a 120-V circuit at the left side of the main electric panel where what appears to be #14 gauge wire is connected to a 20-amp breaker. Typically, #14 gauge wire should be protected at no more than 15amps. Replacement of the oversized breakers is recommended. This condition is illustrated in the accompanying photo.

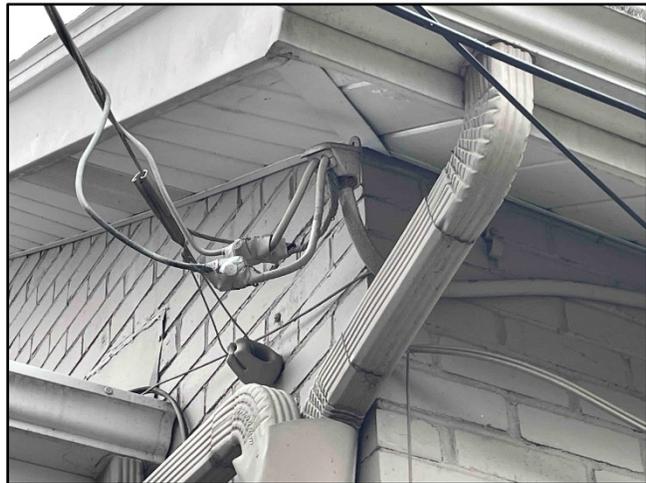
- g. The electric service mount and weather-head were pulled loose from the house. It is recommended that these be reattached to the side of the house. This condition is illustrated in the accompanying photo.

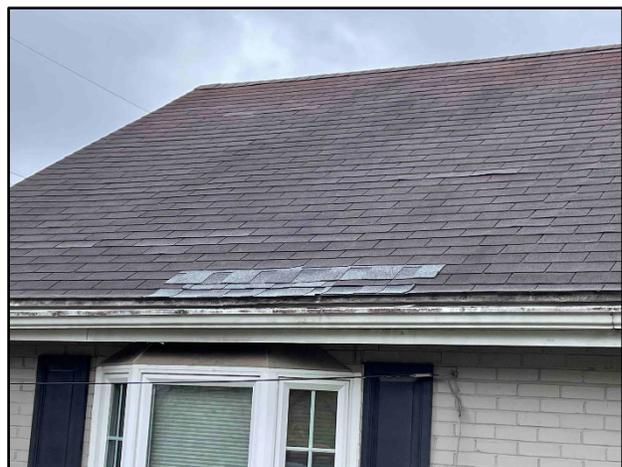
- a. The roof covering consists of a 3-tab asphalt shingle estimated to be approximately 20 - 24 years old. The roof was viewed with a ladder at the eaves and by walking the back porch. Granule loss and cracks were observed throughout the roof covering. The roof was wet at the time of the inspection due to the rain earlier in the day. This can limit some view of cracks and deterioration.
- b. Several shingles had been replaced or repaired along the lower right side roof above one of the bay windows. This suggests past damage. It is recommended that this area be monitored for any signs of ongoing leakage. This condition is illustrated in the accompanying photo.

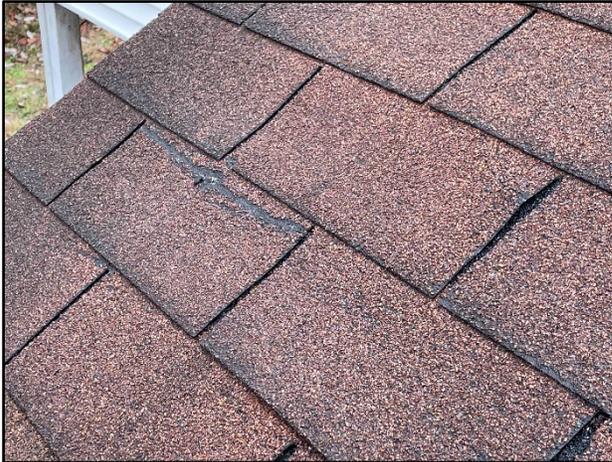
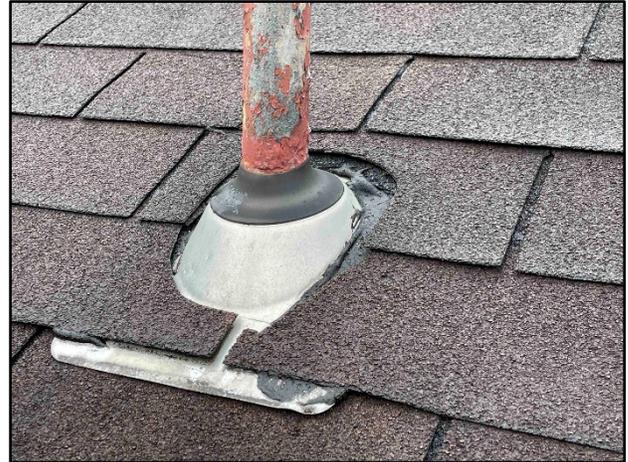
- c. Several deeper cracks were observed to the shingle tabs particularly around the plumbing vent flashings. This condition is illustrated in the accompanying photo above left. This may suggest the plumbing vent flashings have been updated or repaired in the past. This condition is illustrated in the accompanying photo above right. At each of the plumbing vent flashings there was also a layer of tar or roof cement around the flashings suggesting an effort to control past leakage.

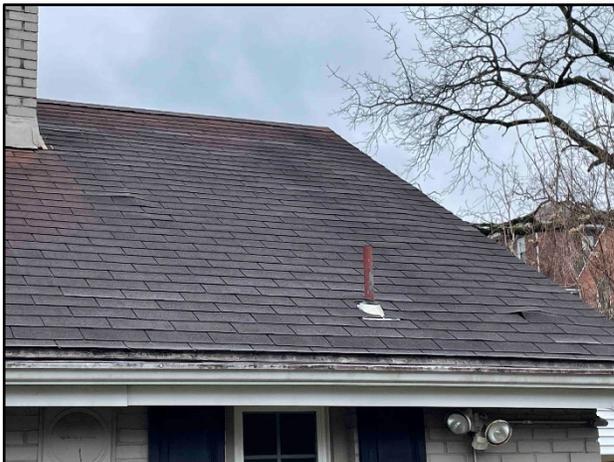
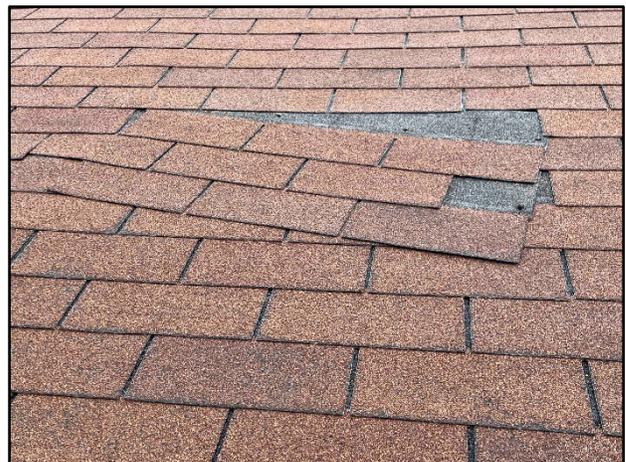
- d. There were numerous nail popped shingle tabs along the right and left side roof. There were also several loose shingle tabs along the left side roof. These shingles will likely pull completely loose in the near future. This condition is illustrated in the accompanying photos above.
- e. The granule loss and cracking was more prominent suggesting the roof is at the end of its typical service life. Given the conditions observed, replacement should be anticipated. You should consult with a roofer regarding the above mentioned items.

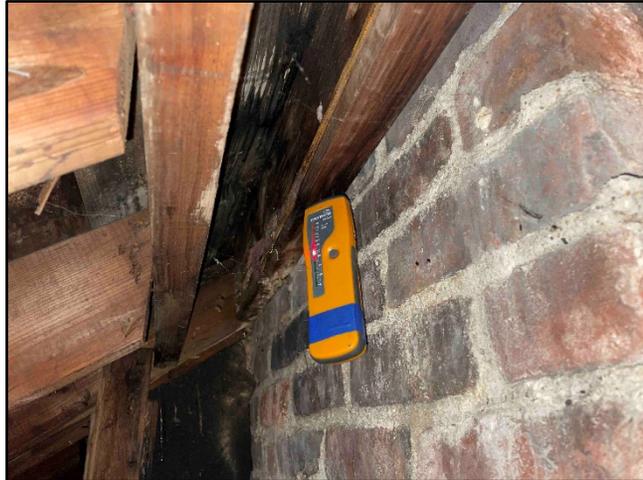
- f. There was daylight shining around the chimney flashing as seen in the knee-wall space. This can allow water penetration. When checking the framing and brick work around the chimney, this was damp / wet at the time of the inspection. This may also be aggravating the damage seen to the kitchen ceiling as well. The flashings should be repaired or replaced during roof replacement. This condition is illustrated in the accompanying photo.

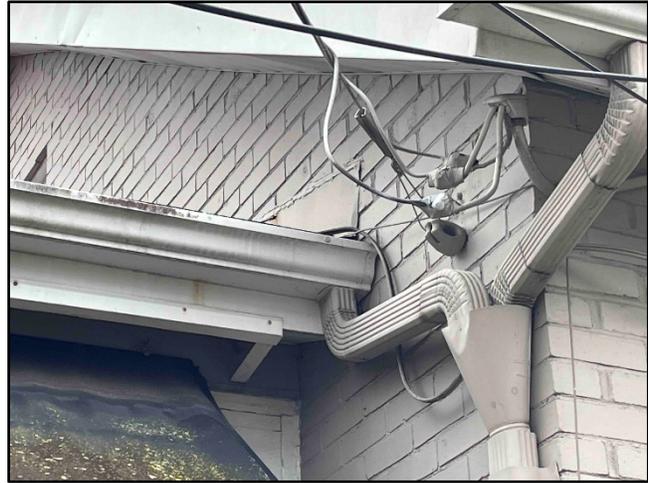
- a. There were moisture stains on the wall below the gutter to the right side of the enclosed front porch. This suggests water bypassing the gutter system. This may be the result of a missing kick out flashing. This condition is illustrated in the accompanying photo. It is recommended that a kick-out or diverter flashing be installed at the bottom of the roof-to-wall intersection where the front porch gutters connect to the house at the left and right sides.

This can help to ensure that water running along the roof/wall intersection does not bypass behind the gutter. You should consult with a roofing contractor regarding this.

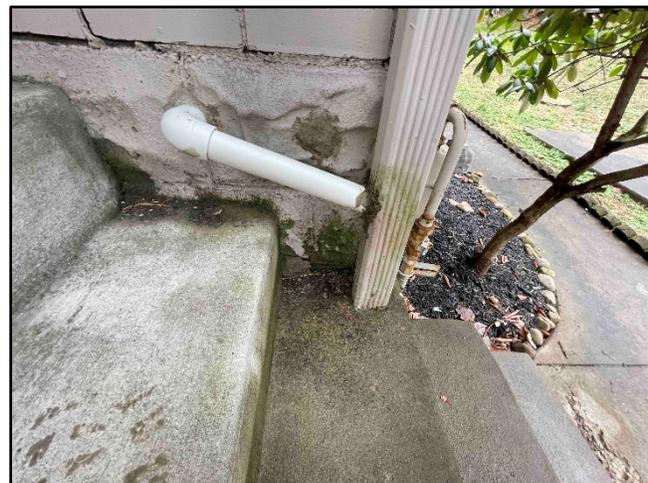
- b. There were stains and moisture where the sump pump discharge pipe connects to the downspout at the front right corner of the house. This may suggest leakage from this fitting. It is recommended that this be evaluated and resealed as needed. This condition is illustrated in the accompanying photo.

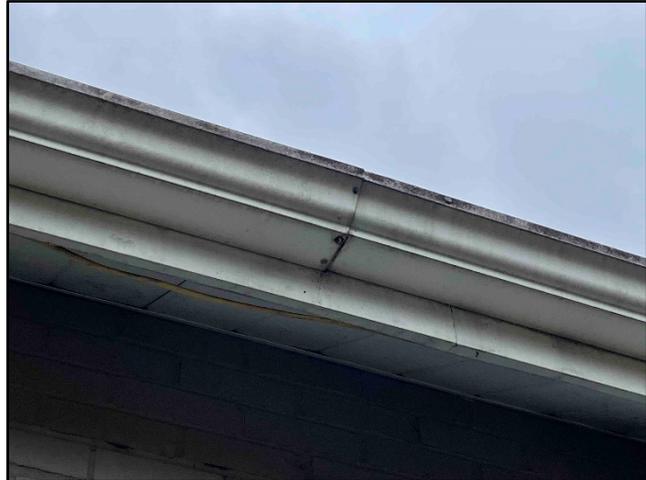
- f. There were dark seams at several areas of the gutter and downspout system. Leakage was observed from some of these areas. It is recommended that any leaking fittings be repaired. This condition is illustrated in the accompanying photo.

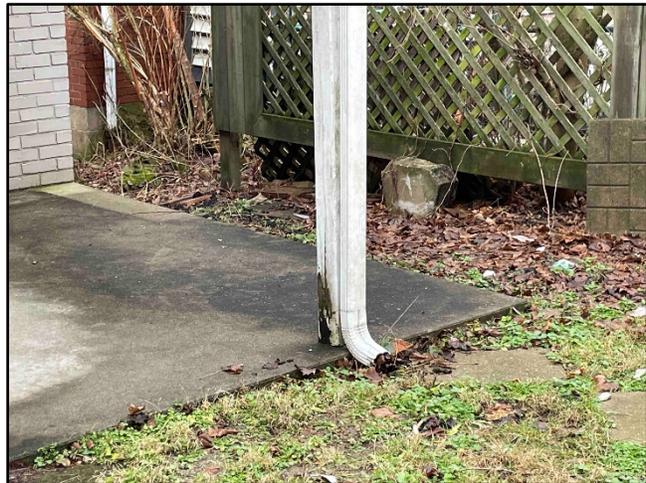
- g. The downspout at the back of the back porch discharges next to the support post and concrete slab. This condition is illustrated in the accompanying photo. This could allow possible settlement from excess water penetration below. It is recommended at all downspouts discharge at least 5' away from any exterior wall or support post. As a future improvement, underground drain pipe should be used.

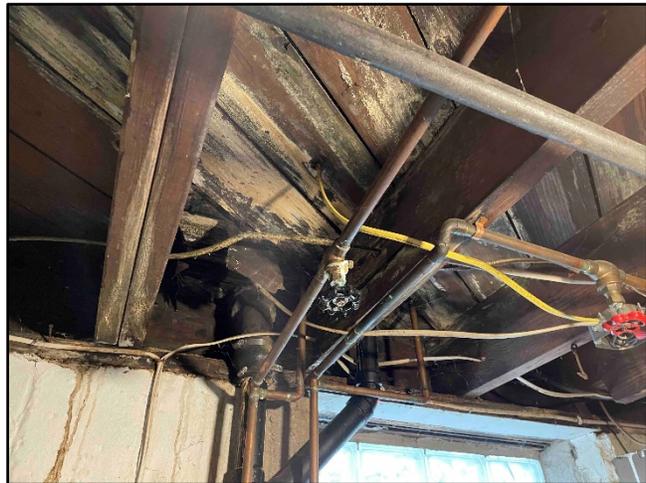
- b. The older cast-iron drain pipe below the kitchen sink was cracked as seen in the joist bay at the back right side of the basement. It is likely that this is still connected to the plumbing vent that runs to the exterior through the roofline. It is recommended that this be evaluated and repaired. This condition is illustrated in the accompanying photo.

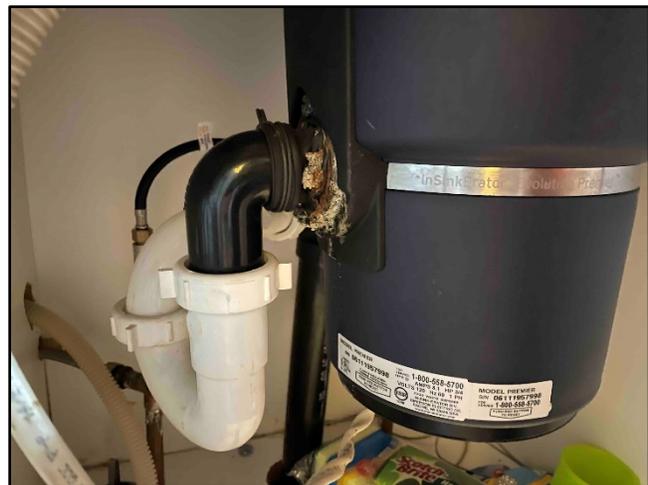
- i. There was corrosion on the fitting where the garbage disposal connects to the drain pipe. There was also suspected seepage at this area. This should be evaluated and repaired. This condition is illustrated in the accompanying photo.

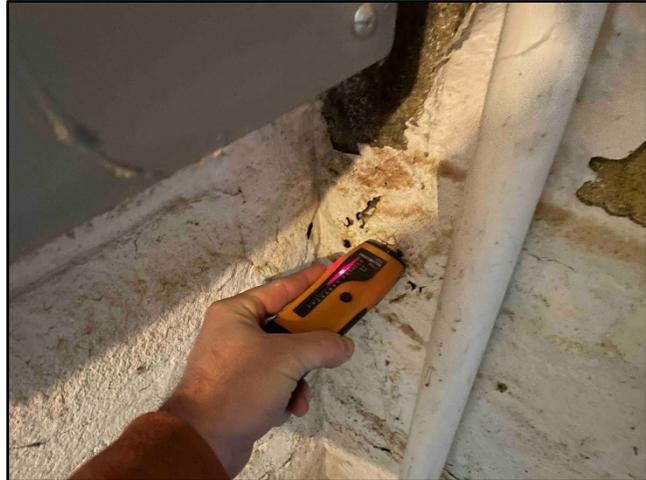
- e. Staining, efflorescence and signs of past water penetration were observed on the foundation walls at various areas of the basement. When checked with an electronic moisture meter, some of these areas were wet or damp at the time of the inspection. Moisture meter readings were between 35% - 45%. This condition is illustrated in the accompanying photo. Some of this moisture appeared to be related to the leakage from the gutter by the front porch (as seen near the electric panel in the garage. Most other damp areas appeared to be related to ground moisture penetrating through the walls.

In general, the house pre-dates the era of modern water-proofing and damp-proofing coatings. A dehumidifier should be operated to help control moisture and humidity at the basement.

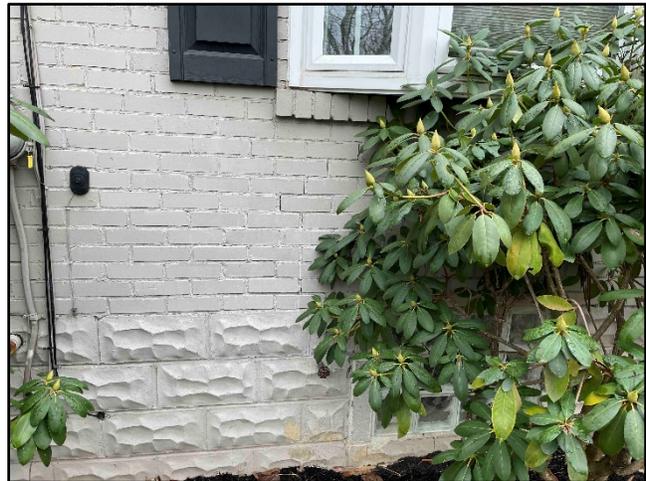
- b. There were step cracks above and below the bay windows at the right side exterior. This was most prominent to the front bay window. It is recommended that these cracks be pointed and repaired. Similar step cracks were observed around several of the other windows to the house. This condition is illustrated in the accompanying photo.

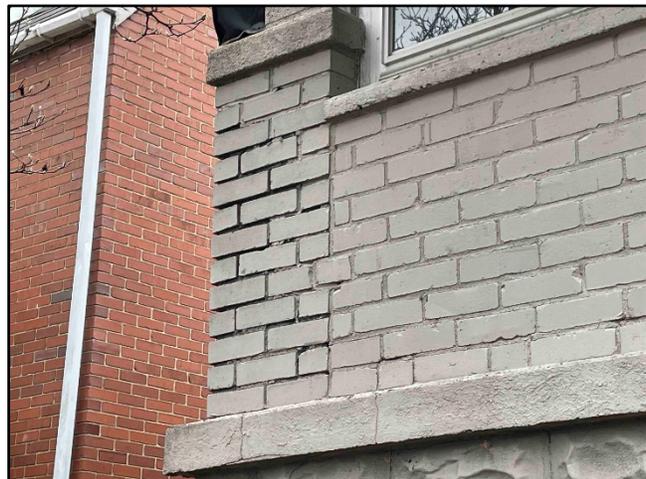
- c. There were areas of loose and missing mortar to the brick pillars at the left and right side of the enclosed front porch. This condition is illustrated in the accompanying photo. There were also a few hairline step cracks along the brick railing. It is recommended that these areas be pointed and repaired.

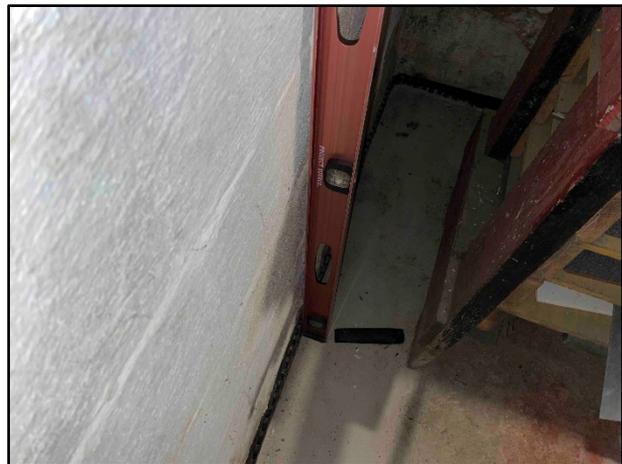
- g. There was a noticeable bulge on the foundation wall at the back right side of the basement. This condition is illustrated in the accompanying photo. When checked with a 4' level, the foundation wall was found to be bulged inward approximately $\frac{3}{4}$ " - 1" in the height of the wall. In general, this amount of movement is not considered to be significant, however it is approaching the threshold. Typically, wherever inward movement over 1" away from plumb is observed, reinforcement of the wall should be considered. It is recommended that the wall be measured and monitored for additional signs of movement.

In many cases, foundation wall movement or bulging is the result of excess saturated soil pressure on the wall, which is often the result of poor drainage at the

exterior. It is important that gutters, downspouts, and underground rain conductor pipes function and drain properly, and that the property be graded to direct surface runoff water away from the house.

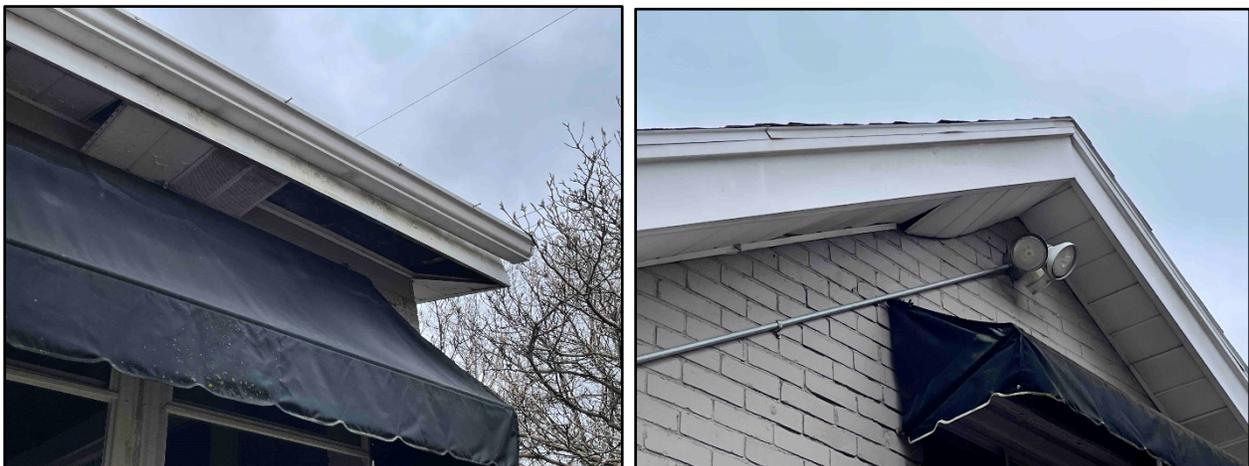
19. The soffit had pulled loose along the left side of the front porch. This could allow birds or rodents to enter into the framing. It is recommended that the soffit be reinstalled. This condition is illustrated in the accompanying photo above left.

Some of the soffit was also pulling loose along the back upper roof. It is recommended that the soffit be reattached. This condition is illustrated in the accompanying photo above right.

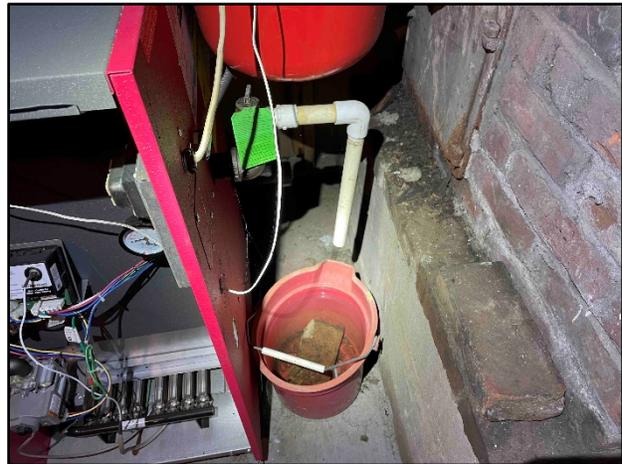
A bucket had been placed below the temperature pressure relief valve discharge pipe. This condition is illustrated in the accompanying photo. This was filled with water. During the inspection, the valve continuously discharged water. It also appeared that the boiler's pressure raised to approximately 35psi. This is not recommended. This should be evaluated by an HVAC contractor.

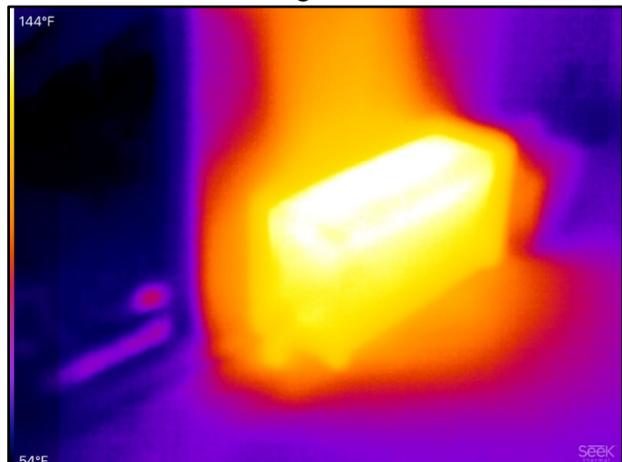
There was minimal heat observed to the basement radiators in the left room. This may suggest

air was trapped in the pipes. It is recommended that this be evaluated.

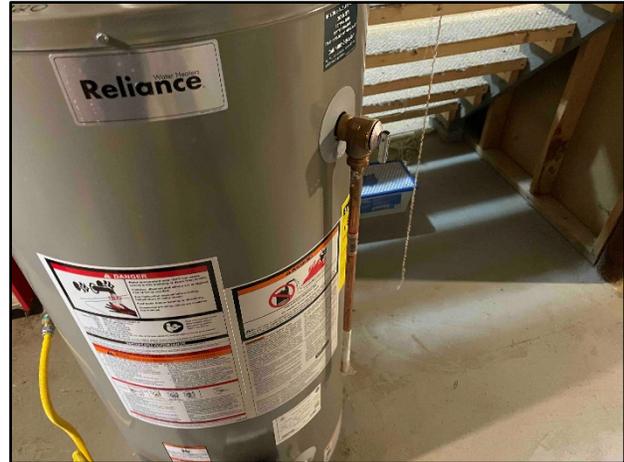
- b. The temperature to the hot water tank was raised and the burner was activated. The hot water tank appeared to function properly at the time of the inspection. The hot water tank was drafting properly and was checked with a Testo 317-3 CO detector and no excess levels of carbon monoxide were observed at this time.
- c. The extension pipe from the temperature/pressure relief (TPR) valve of the hot water tank has been reduced to ½" copper pipe. This condition is illustrated in the accompanying photo. A minimum of ¾" pipe is recommended for the entire length of the pipe to accommodate flow in the event of a discharge. This should also discharge approximately 4"-6" off the floor. Installation of a larger pipe is recommended.

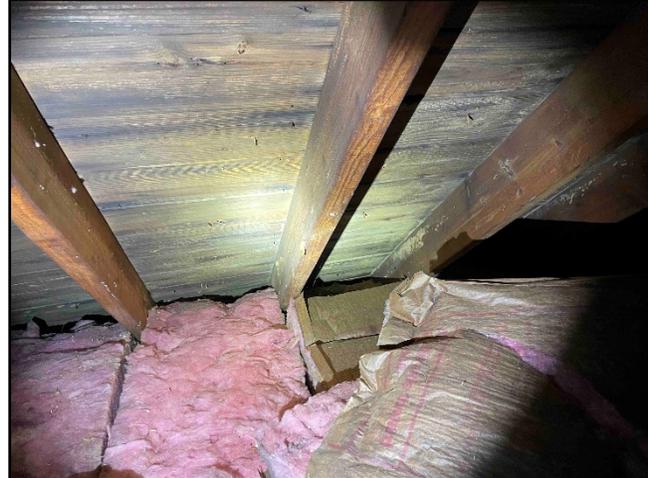
- a. There is concern that there may not be appropriate ventilation for the roof/attic. Proper ventilation helps to remove excess moisture and humidity from the attic cavity by encouraging airflow through the attic. As a general rule, there should be one square foot of free-vent-area for every 150-300 square-feet of attic area. Installation of additional ventilation is recommended. In many cases, this is achieved by adding a ridge vent whenever the roof covering is replaced.

There were a few stained areas on the roof deck, where it was visible from the knee-wall space. These stains are suspected mold growth. It is not in the scope of this inspection to test for evaluate for mold. If you have concerns with this, you should consult with a mold specialist. This condition is illustrated in the accompanying photo.

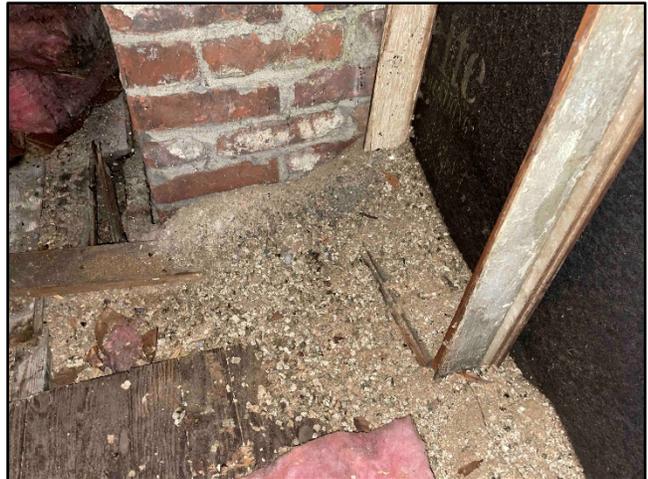
- b. Vermiculite insulation was observed in the attic near the chimney. This condition is illustrated in the accompanying photo. Some varieties of vermiculite insulation are known to be asbestos-containing. Laboratory analysis is needed to positively identify asbestos. Identification- and analysis- of possible asbestos materials is beyond the scope of this inspection. Links to additional information on asbestos is available at the [Technical Links](#) page of our website. Additional concerns should be addressed to an Asbestos specialist.

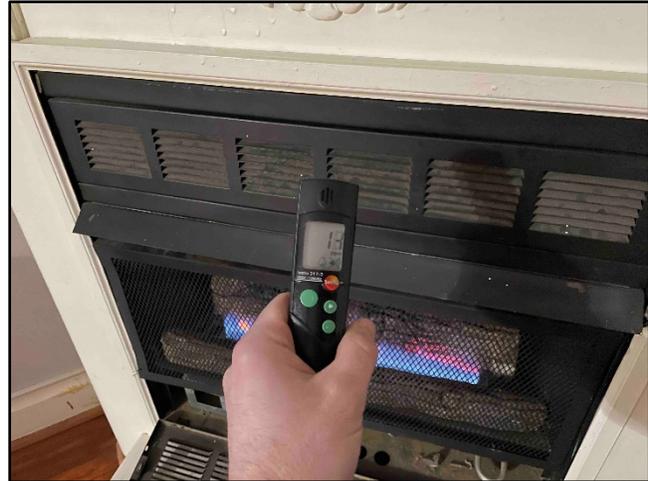
25. There is an unvented gas log fireplace in the living room. The fireplace was lit and operated for several minutes. Placement of the ceramic logs is critical to proper operation. A carbon monoxide test was performed in the vicinity of the fireplace using a Testo 317-3 CO detector and levels of approximately 10-15 ppm were observed. This may suggest the burner is dirty. This condition is illustrated in the accompanying photo. In addition, the pilot would not light with the ignitor. A separate lighter had to be used to light the fireplace. Consult with a fireplace technician regarding repair to these conditions.

Most manufacturers recommend that a window be opened in the room when the appliance is on, a carbon monoxide detector should be placed in the room and one should never fall asleep in the room with the appliance on. Placement of the ceramic logs is critical to proper operation. It is recommended that you obtain a copy of the manufacturer's literature regarding proper log placement, cleaning and maintenance.

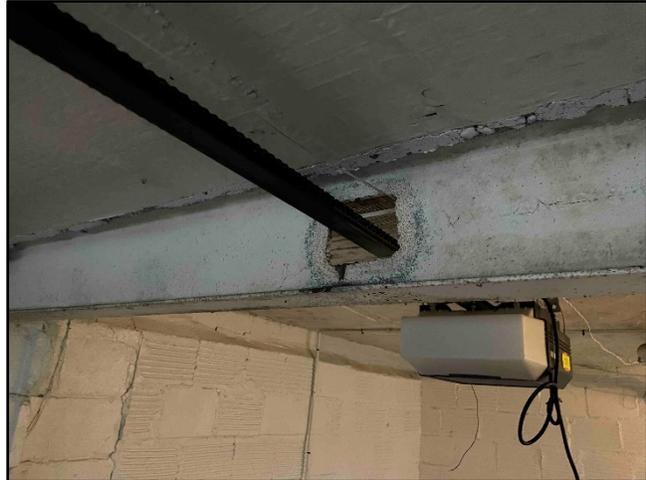
28. There was a hole cut out of the steel I-beam in the center of the garage for the installation of the garage door opener. This condition is illustrated in the accompanying photo. It could not be determined with certainty if this compromises the structural stability of the steel I-beam. It is not considered best practice to notch or cut an I-beam. You should consult with an engineer regarding this. There did not appear to be slope or sag observed at this time. At minimum, it is recommended to monitor this area.

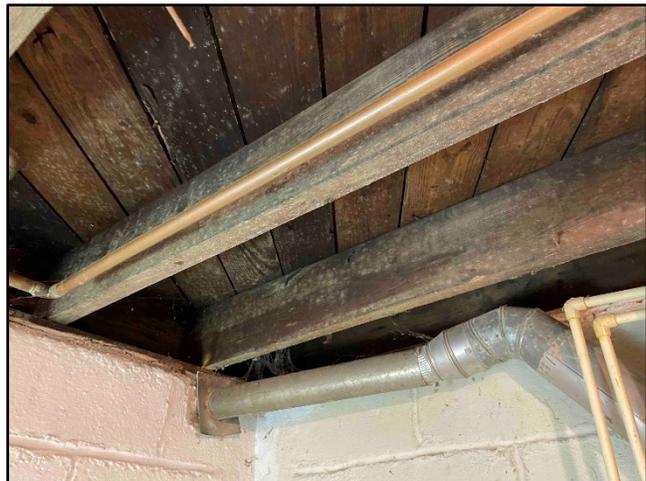
32. Possible mold substances were observed on several joists and floor boards along the back of the basement above the laundry area as well as below the kitchen. This condition is illustrated in the accompanying photo. Lab sampling or analysis of possible mold substances is beyond the scope of this inspection. If this is a concern, you should consult with a mold expert or an industrial hygienist. In general, mold substances are considered to be a symptom of an underlying moisture problem. Cleaning/removal of the affected materials is recommended.
