HOME BUYER REPORT

Buyer Name
Buyer Address
Pittsburgh, PA 15220

Inspection Date and Time
Inspection Address
Jason Greenawalt
\$XXX Total Fee
\$XXX for general inspection
\$XXX for wood destroying insect inspection
\$XXX for radon inspection

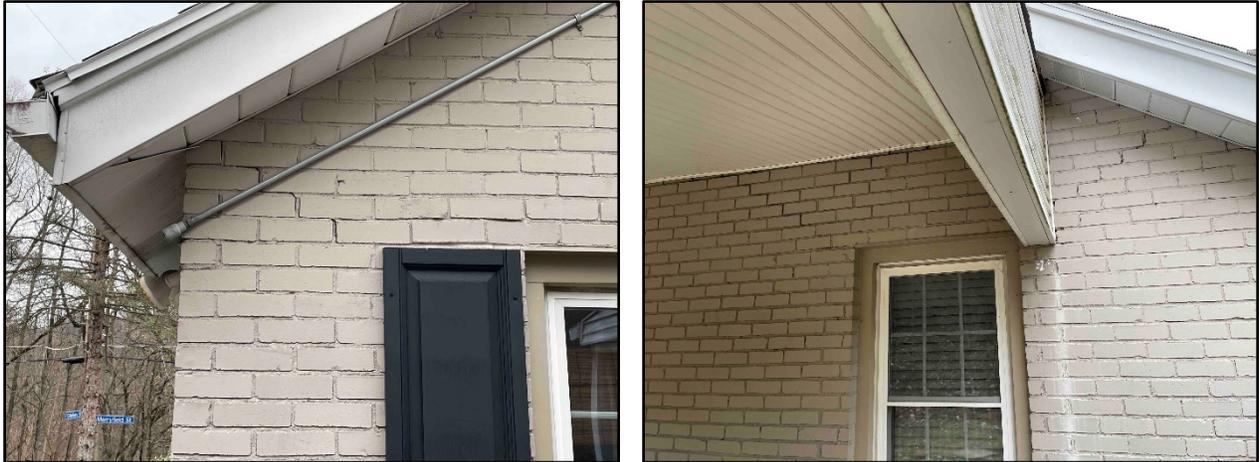
- d. There were step cracks at the back right corner of the house extending from the window up to the roofline. It is recommended that these cracks be pointed and repaired. A similar condition was observed along the back left window that extended up towards the roof line. This condition is illustrated in the accompanying photos above.
- e. Step cracks with slight sheared offsets were observed above the front left side window. It is recommended that these cracks be evaluated and repaired.
- f. There were a few step cracks to the foundation walls seen in the basement and the garage. This condition is not uncommon. The walls were checked with a level around the perimeter. Most areas were found to be plumb, aside from the back wall as mentioned below. Any cracks should be pointed and repaired.
